Case Study

Silver Ranch Dam Repair- Texas

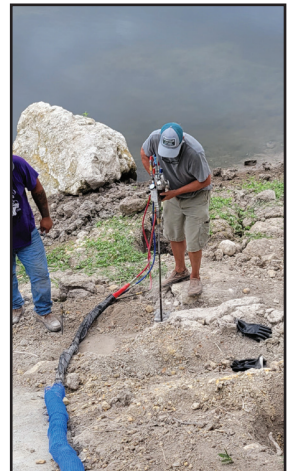
Rapidly changing high and low water conditions caused substantial erosion at the edges of the poured dam wall. This eventually led to two leaks when the reservoir was at its normal water level.

32 locations around the two leaks were selected based on the direction the leak was flowing. Injection pipes were installed to a depth of 4ft at the water's edge. As the pipes were installed higher up the slope, they were driven deeper to achieve an injection depth at the current water level. This was around 8-9ft depth. In the first round, an average of 25lbs per point was injected into each location.

A second round of injection pipes were installed adjacent to the first, but at shallower depths. Starting at 3ft and following the grade up, the injection pipes were installed down to 6ft. An average of 25lbs per injection location was used in the second round. Three Deep Foamjection rods were driven under the dam wall horizontally where the erosion had washed out dirt from under the concrete. These were driven in approximately 9ft. 215lbs of material was used between the three locations to fill the void.
