CASE STUDY - WATERPROOFING A CRITICAL TELECOMMUNICATIONS FACILITY

• Yorkton, Saskatchewan - Canada •

PRODUCT USED: HMI SOIL LINK™ ACRYLATE GROUT

APPLICATION: Crack Sealing & Water Infiltration Prevention.

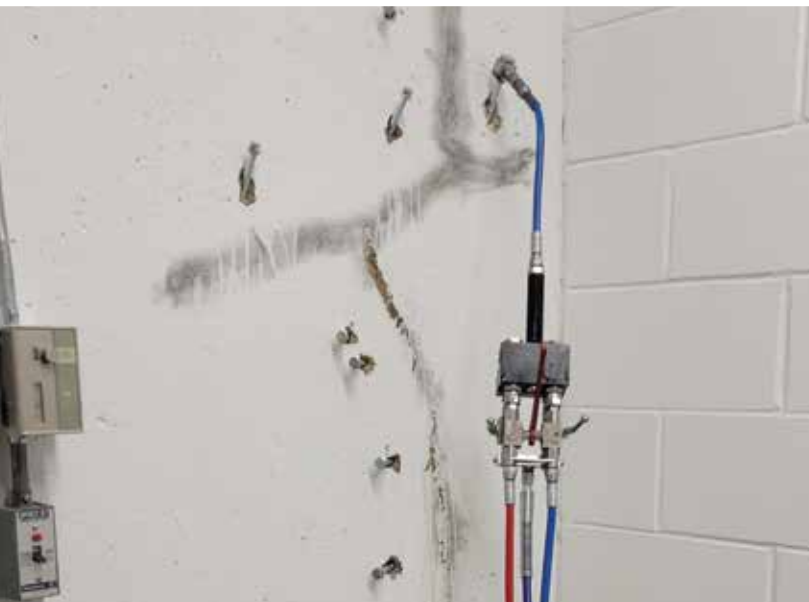
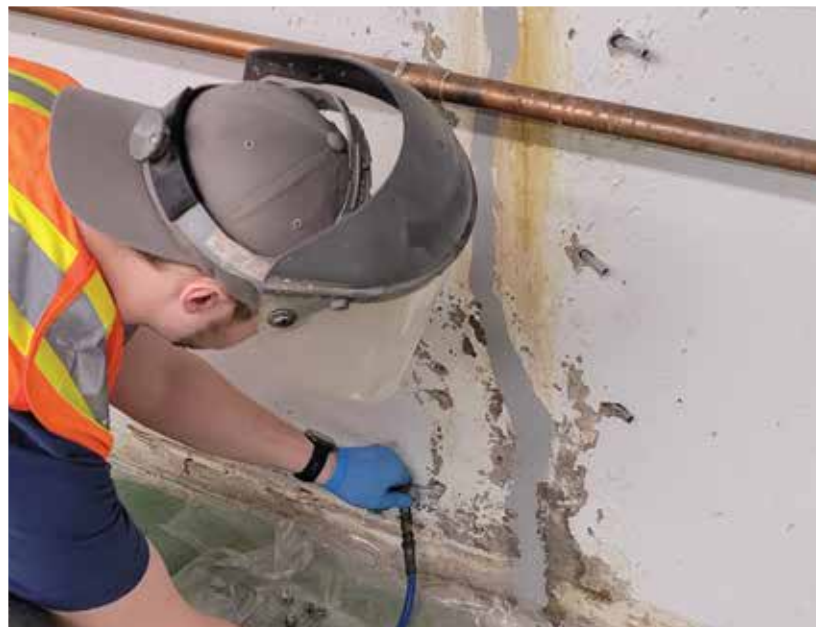
A telecommunications switching station was facing chronic groundwater infiltration that threatened highly sensitive electrical equipment. The water intrusion stemmed from foundation settlement and was traced to four significant cracks in the structure's thick concrete walls:

- Two full-length cracks (10 feet each)
- Two six-foot cracks, one of which was actively leaking

Unlike residential foundations, the unusually thick walls at this facility presented added complexity in sealing efforts. A long-lasting, fail-safe waterproofing solution was critical to prevent operational disruptions.

Due to the age of the wall, thickness, and the need for a permanent solution without error to protect sensitive electrical equipment, a geotechnical engineer recommended HMI's Soil Link™ Acrylate Grout to provide a watertight seal.

The standard six-step interception process was modified to have an acid flush instead of water, when water testing, to ensure adherence by first cleaning the cracks of any dirt, organics, mold and debris built up over the many years. Hydraulic cement was also used when sealing the crack with an active water leak to ensure seal adherence.

The cracks were successfully sealed with HMI's Soil Link™ Acrylate Grout stopping water infiltration in its tracks. After an acid base flush cleaned out dirt, organics and debris, the low-viscosity acrylate gel effectively permeated the narrow and leaking cracks, forming a long-lasting waterproof barrier. Thus, effectively protecting the sensitive electrical equipment and solving the problem.
