Sweden Case Study

Deep FoamjectionTM

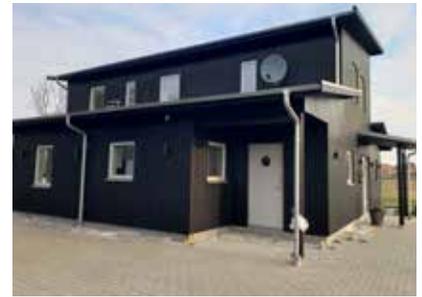
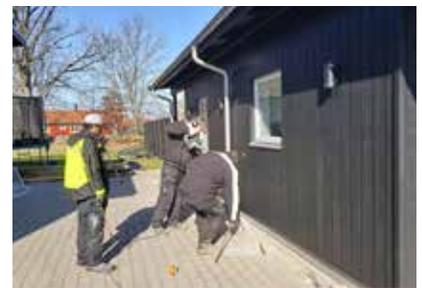
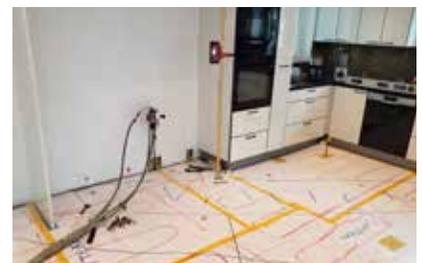
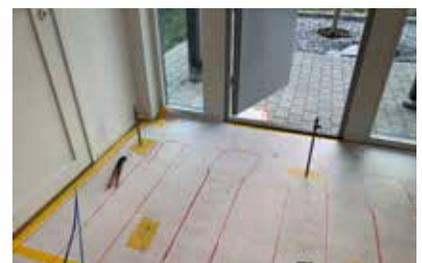
1. Per Sweden's building code, there is 2.5 ft of insulation board directly under the homes flooring. Therefore the injection would need to start that much deeper to address the failing soils.
2. A waterproof membrane was directly under the utility room that could not be punctured, therefore no drilling could be done in the utility room. This room would have to be lifted and stabilized from outside the home and the perimeter of the room (inside the kitchen)
3. The entire home had radiant in floor heating, the local fire department used infrared technology to detect where the heating lines were located. These were indicated with red lines on flooring paper put down throughout the entire home. The blue lines indicated the boiler heat for the home. (Shown in photos to the right) Because of this there were large areas of the home that could not be drilled down into.

The contractor started outside on the most settled corner of the home. All outside pipes were angled to get material underneath the slab and foam board insulation. They installed pipe 6-9 feet, 4 feet below the insulation board. A soil boring report indicated what depth the weak soils were at. A plural component material was injected into the ground. The material expanded into foam that added strength to the soil as it expanded. As more foam was installed pressure was built to lift the slab.

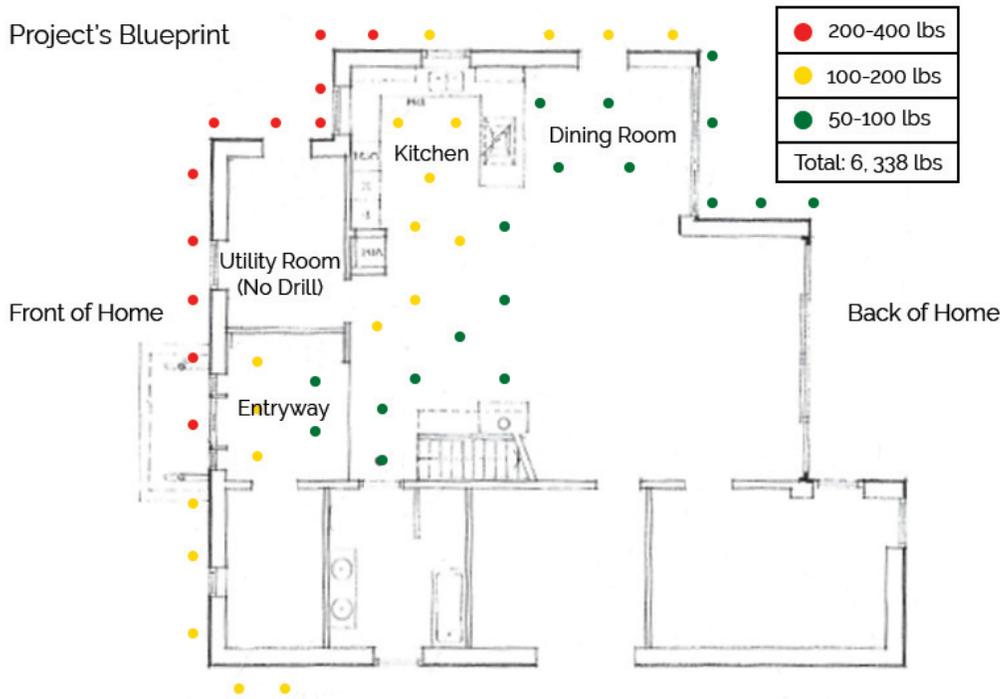
Project's Blueprint

This map identifies that areas where material was injected to stabilize and lift the slab. The areas in red received the most foam where the slab was raised up to 3 ½ inches. The yellow and green areas supported the lift and stabilized the slab.
