## CASE STUDY - FAILING SEA WALL SOILS REPAIRED AT MINIMAL COST & NO EXCAVATION

St. Petersburg, Florida

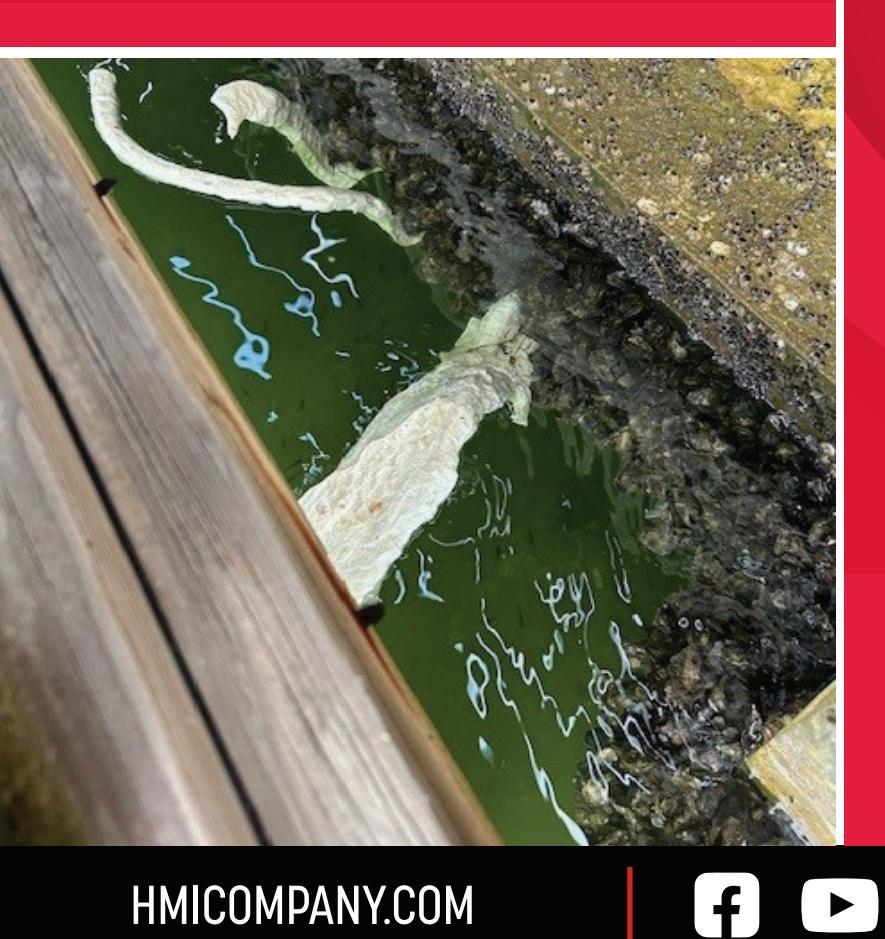
To address the soil piping and stabilize the soil behind the seawall, the decision was made to conduct permeation grouting using a single-component polyurethane foam. This material was chosen for its effectiveness in stabilizing soil, filling cracks and voids, while being minimally invasive with no excavation or large equipment. The ability to adjust the reaction time on-site, through mixing adjustable amounts of catalyst, would allow the material to permeate through the soil, ensuring comprehensive coverage. The permeated material would also penetrate unseen gaps or cracks beneath the waterline before expanding to seal off those channels for soil loss. (As pictured below)

**Pre Injection**

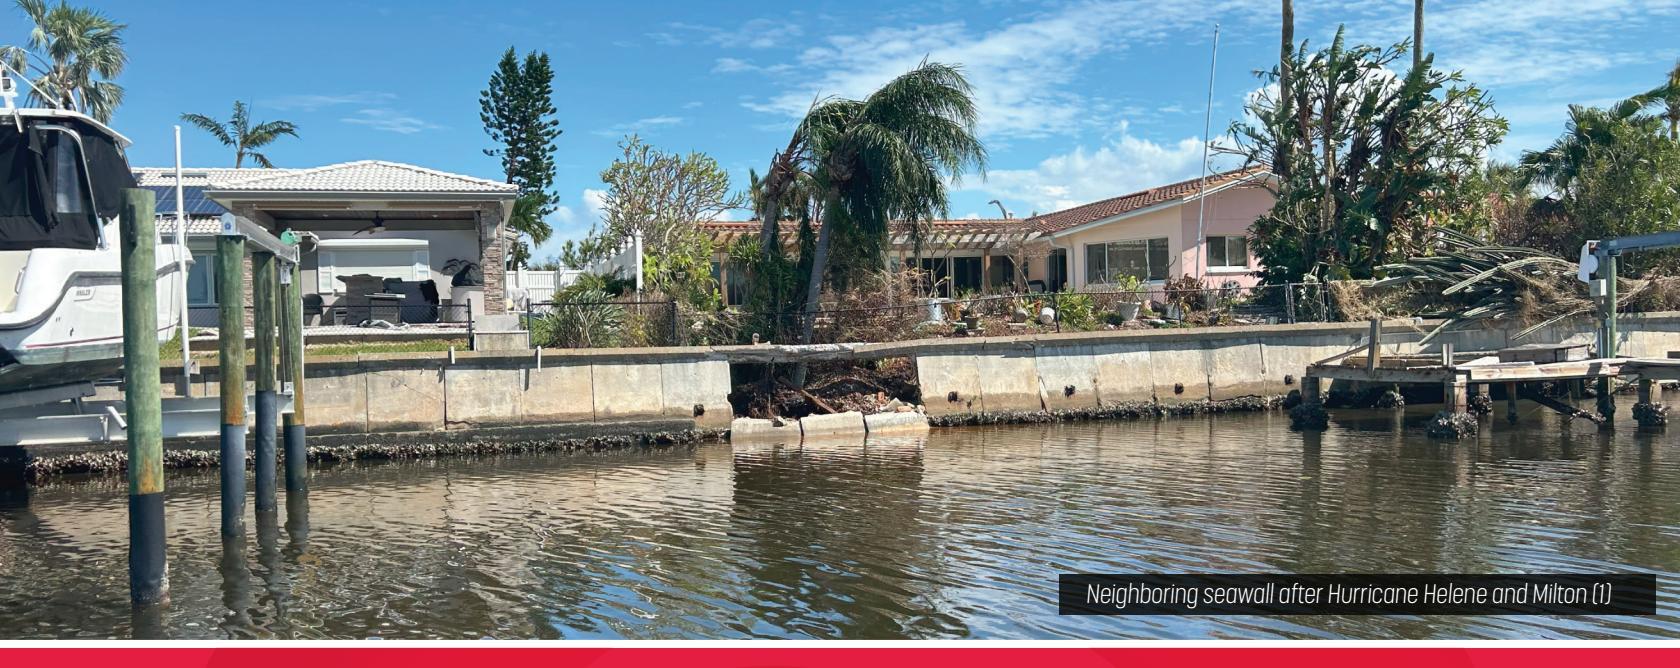
Comparisons of the DCP test results before and after injection showed a 699% improvement in the California Bearing Ratio (CBR) between the treated depths of 3 to 10 feet at the first location and a 277% improvement at the second location. The injection process effectively addressed the underlying soil piping issue, improved the stability of the loose soil behind the seawall, and provided a long-lasting solution with no environmental impact by plugging spots of water ingress and filling voids. The success of this project demonstrates the viability of single component polyurethane foam as a repair material for similar coastal infrastructure challenges.

An engineered plan, determined by pre-injection DCP (Dynamic Cone Penetrometer) and probe testing, resulted in injection probes that were driven to a depth of 10 feet below grade spaced approximately 1.5 feet on center. The material was pumped using a lightweight and portable specialized airless paint spraver. Pre-determined volumes of foam were injected from the depth of 10 feet to 3 feet below the top of grade before moving to the next probe. Approximately 155 linear feet of seawall was treated using this method. After completion of injection a Dynamic Cone Penetrometer (DCP) test was repeated to provide an assessment on the effectiveness of the soil improvement.

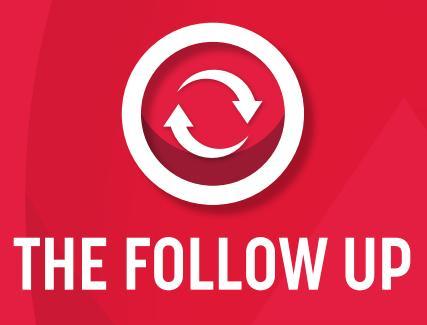
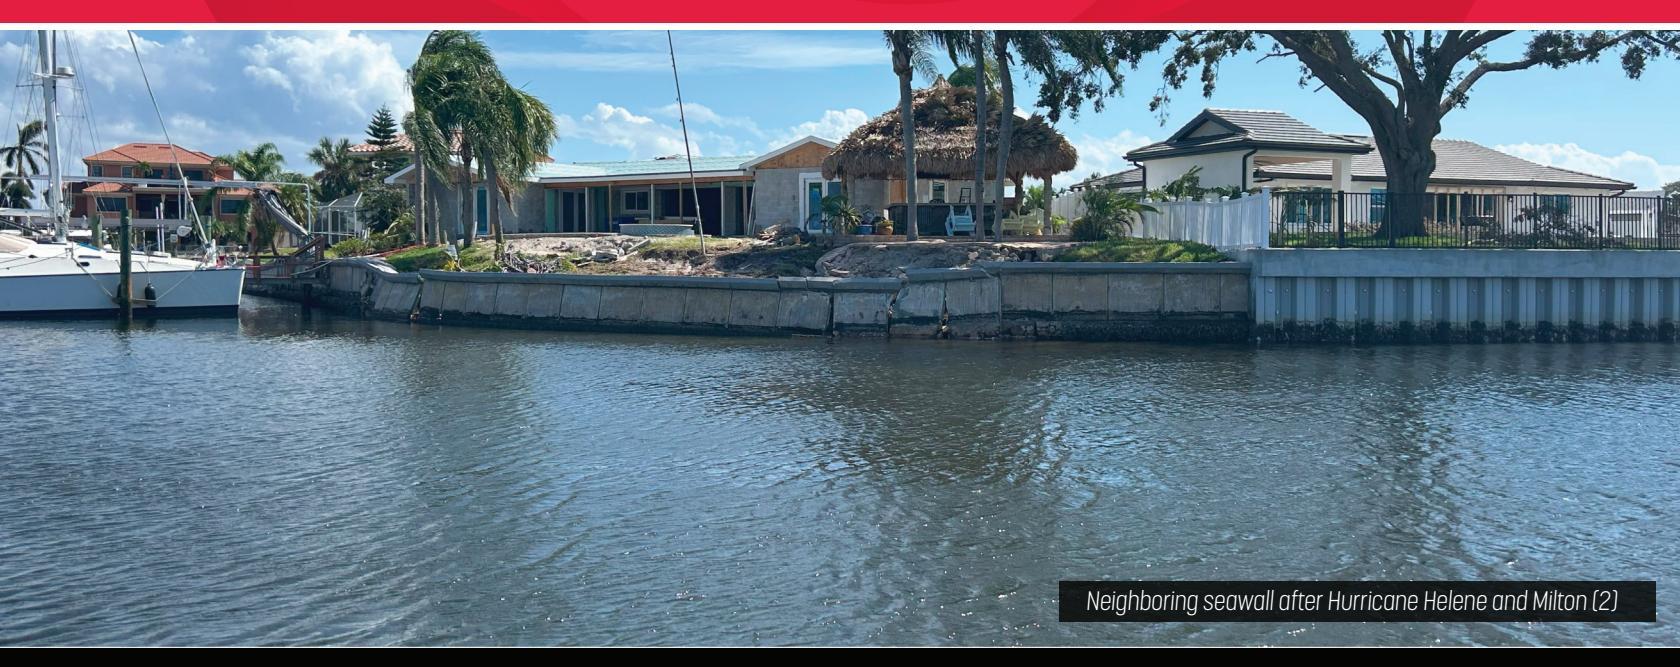
Post Hurricane Helene and Milton Update.

In June 2024, permeation grouting using HMI's single component polyurethane foam was completed on the subject seawall just ahead of the hurricane season. When catastrophic Hurricanes Helene and Milton struck within a two-week period - producing storm surges that exceeded the wall's height - the treated seawall held firm. Unfortunately, many neighboring untreated seawalls experienced catastrophic failures from soil loss near the bottom of the wall (as seen in photos). However, the treated seawall remained intact with no observable soil loss or wall movement.

HMI's repair methodology accurately identified the necessary treatment depths and potential failure mechanisms during the initial assessment before grouting with our single component polyurethane foam. Comparative DCP tests, conducted before and after the injections, confirmed a significant increase in soil strength to increase global stability of the seawall. We are proud to say that the HMI seawall repair methodology not only stabilized and extended the lifespan of the seawall but also prevented a catastrophic failure.
