# Case Study

## Highway 1 Stabilization

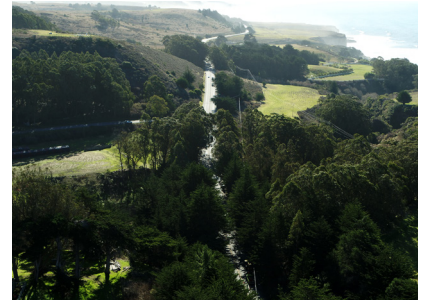
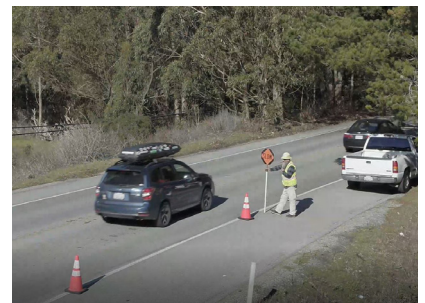
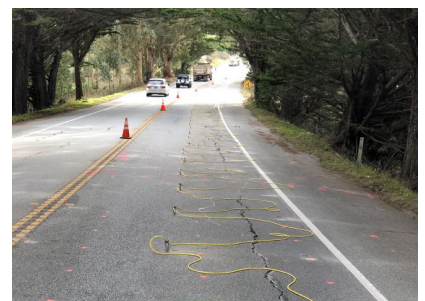
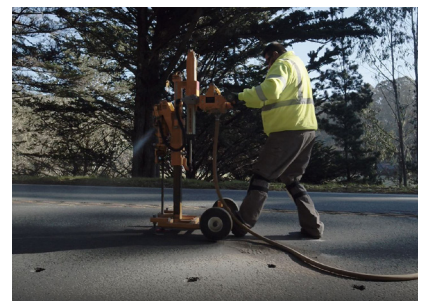
A 300 foot section of Historic HWY 1 was experiencing some cracking and road faulting. After engineers tested the roadbed, it was discovered that there was poor soil compaction ranging 3-12 feet under the highway. HWY 1, is a major road connecting communities from Los Angeles all the way up to San Francisco. This historic highway is a scenic drive that most choose for their daily commutes. When the California Department of Transportation (CALTRANS) planned to complete maintenance on the highway, they needed to take into consideration the shut down time and how it would impact residents commuting for work. They estimated a complete shut down of the highway would add hours onto their uninterrupted commute time. CALTRANS needed to find the best solution to stabilize this roadbed without a complete shut down.

#### Pre Injection Test

#### Post Injection Test

One option was to shut the road down and have heavy equipment come in to rebuild the road, this option would have huge impacts on the environment and community. CALTRANS choose to do a customized plan to stabilize the road and ground below using HMI polyurethane foam by a local concrete lifting company. They first pre-drilled their grid pattern; which the engineers requested to be 3 feet apart. Next, they inserted pipe 3 feet down, and pumped polyurethane until they had movement. The team monitored the movement using multiple laser levels. Once they had a 3 foot layer of foam installed, they injected deeper at 12 feet down until there was movement detected. They pulled the pipe up to 9 feet and again pumped until there was movement. Each hole averaged approximately 60 lbs. of material. Some points took more than 200 lbs. of material until they were able to see movement.

The team was able to keep traffic moving, and completed work on one lane at a time. After all the injections were complete, they were able to resurface the newly stabilized road. They did all this with minimal impact to the environment and community. When they were not working on the road CALTRANS was able to open both lanes so there was no impact at all. The project only took 15 working days to complete. A total of 37,800 pounds of HMI HF 402 polyurethane was injected beneath the failing road. The engineering team completed a final analysis to show the difference they were able to achieve beneath the roadbed. A huge success for the local residents and tourists to enjoy the scenic drive once again with no worry!
