## CASE STUDY - BRIDGE LIFT

• Burnaby, BC •

**AT A GLANCE:** Many parts of the Greater Vancouver have constant ground settling, causing buildings, roadways, and a variety of structures to drop over the course of time.

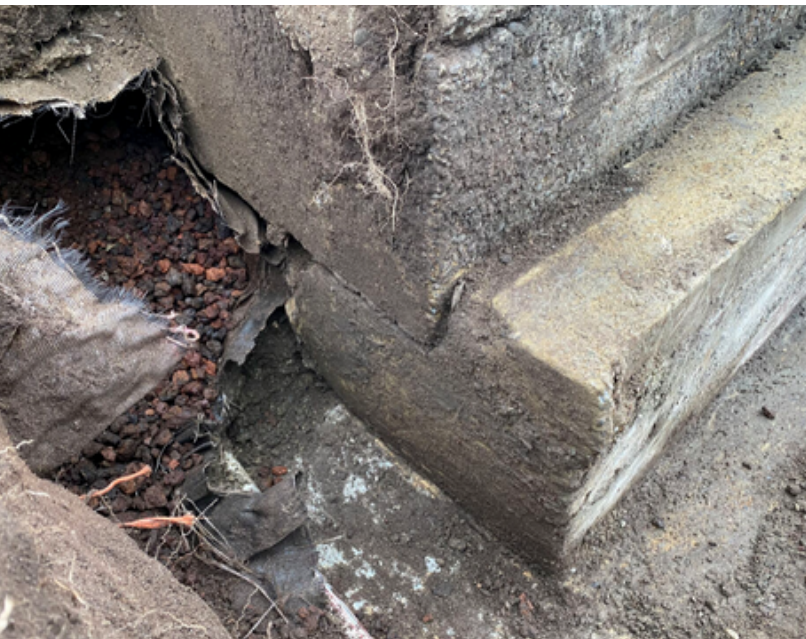
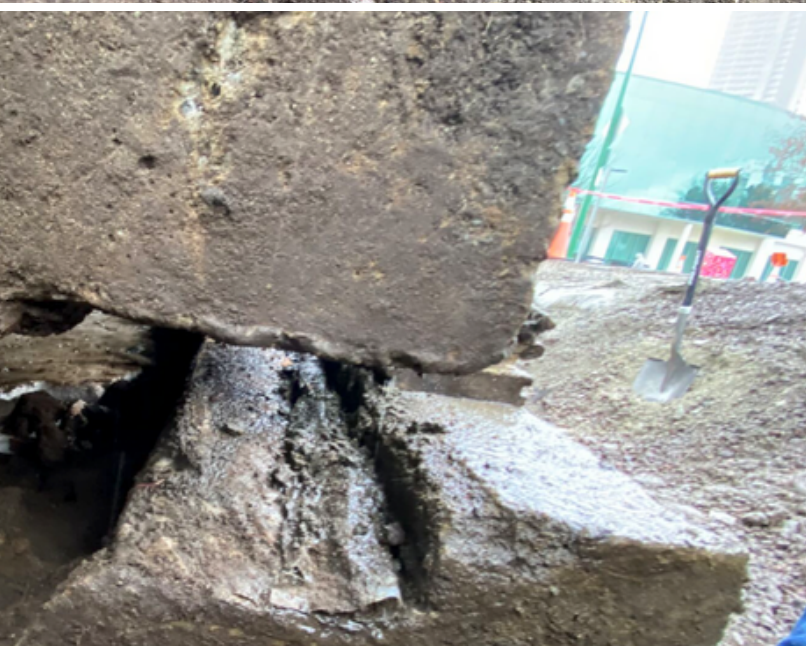
While the bridge deck sits on piles, the approach ramps are hinged on the bridge to allow even, gradual settlement between the asphalt roadway resting on the grade and the bridge. After many years, the slope of the ramp became too great for traffic, causing almost a “jump” at the hinge point. This was also a high traffic location which could not allow the full bridge to be shut down for any length of time.

A technique was designed to efficiently lift the hinged bridge slab and inject HMI polyurethane below a portion of the concrete to support it. Using hydraulic jacks and a fast setting high density polyurethane, the crew was able to lift and support the bridge section up 220mm using 19.5 cubic meters of polyurethane.
