# Case Study

## Kentucky Riverport

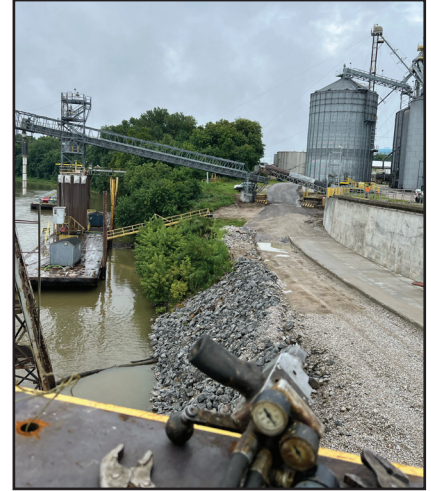
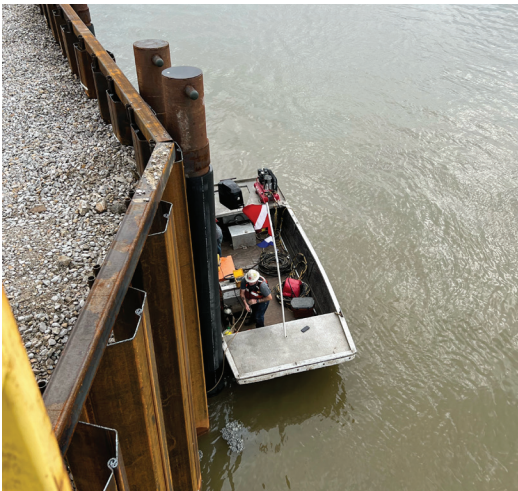
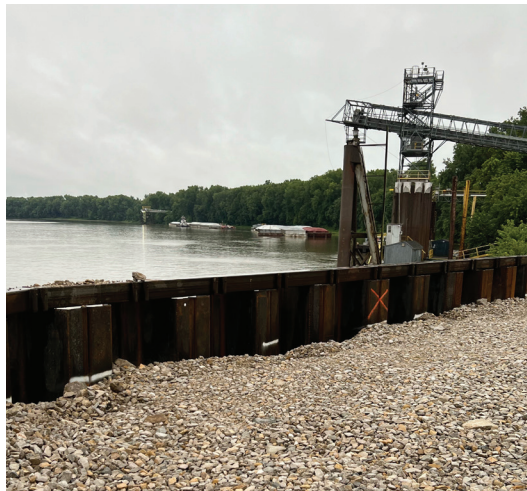
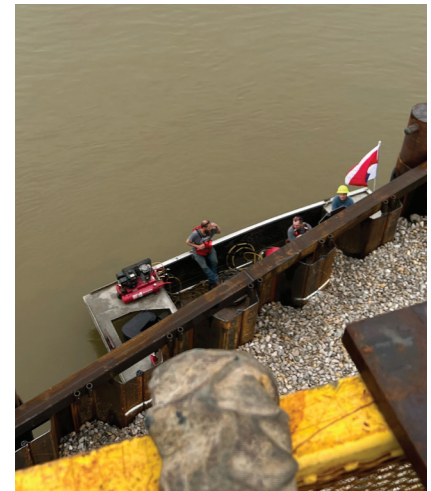
A Riverport in Kentucky contacted their local polyurethane concrete lifting and void filling contractor to assist with a new construction project. When installing metal pilings on the bottom of the river, the construction crew ran into a rock shelf. The rock shelf kept the pilings from being able to be driven down and caused voids along the bottom of the pilings.

The void filling contractor teamed up with a construction company and a team of underwater divers to inject the foam and fill the voids at the bottom of the pilings. The pilings were approx 20' deep in the river. The river divers swam down and pushed the ground rods over to the edge of the void and into place. The crew used a crane basket to lower down to the surface of the water. Once in position, the polyurethane crew gave a series of injections into the void until it was completely full of foam.

Deep Foamjection with HMI's HF402 was chosen to fill the voids due to the large body of water and wet conditions. HydroFoam was specially designed to resist hydrolysis, the chemical process of water breaking down a compound. Designed not only to set up in the presence of water, but to maintain dimensional stability, HydroFoam was the best solution for the job.
