## CASE STUDY - INNOVATIVE SOLUTION HALTS WATER INFILTRATION IN POWER COMPANY'S SWITCHYARD

Single component polyurethane foam technique saves costs and ensures long-lasting protection against manhole flooding and soil loss.

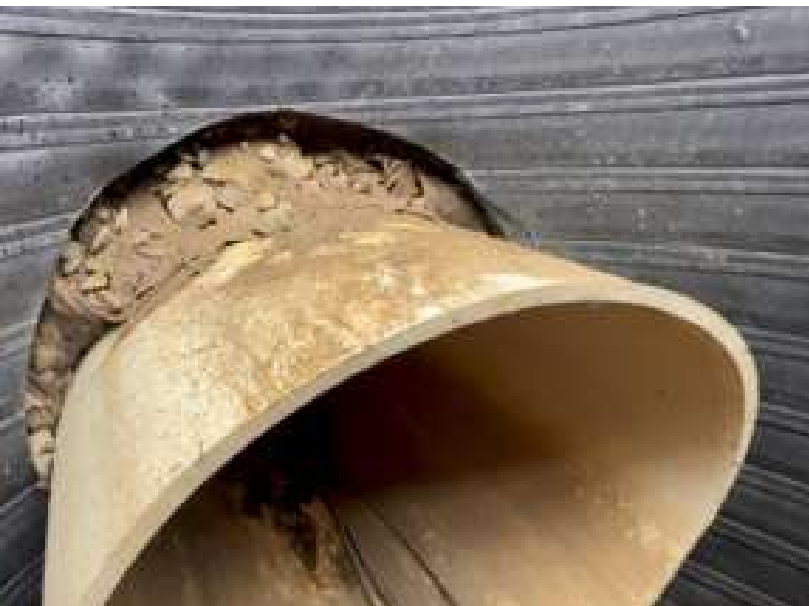
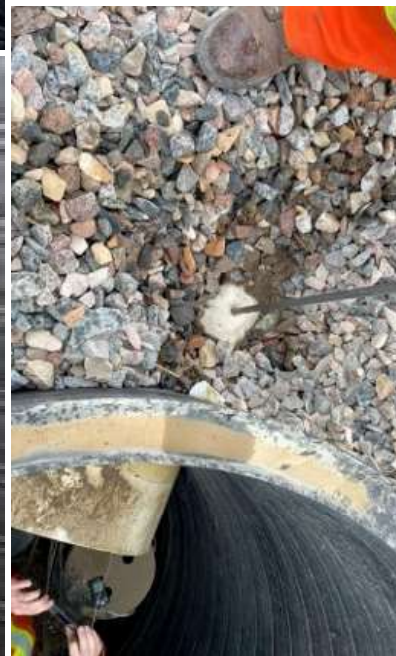
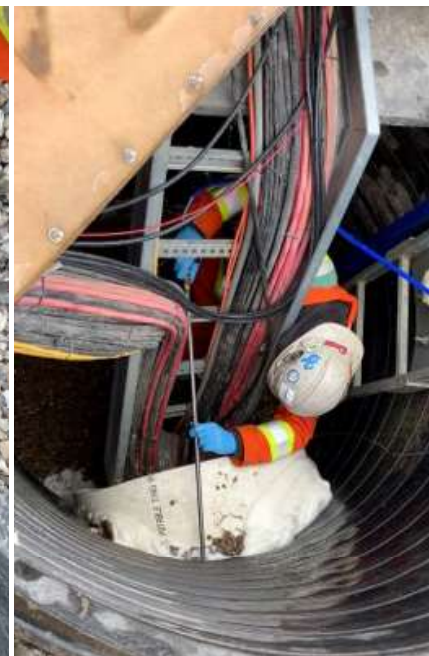
A Canadian power company faced a critical issue with water infiltration in a manhole at one of their switchyard facilities. The manhole, made from semi-flexible plastic, had developed a gap between its structure and the utility lines entering it. Over time, this gap widened, leading to soil loss and the settlement of the soil surface around the manhole. Periodic flooding of the manhole became a significant risk, raising concerns about potential power outages. To mitigate this, sump pumps were installed at the bottom of the manhole, and the site required continuous 24/7 monitoring to manage the water infiltration.
