CASE STUDY - FAILING SEA WALL SOILS REPAIRED AT MINIMAL COST & NO EXCAVATION

St. Petersburg, Florida

SINGLE COMPONENT POLYURETHANE: Ideal solution for sealing cracks, stabilizing soils, and extending the lifespan of sea walls.

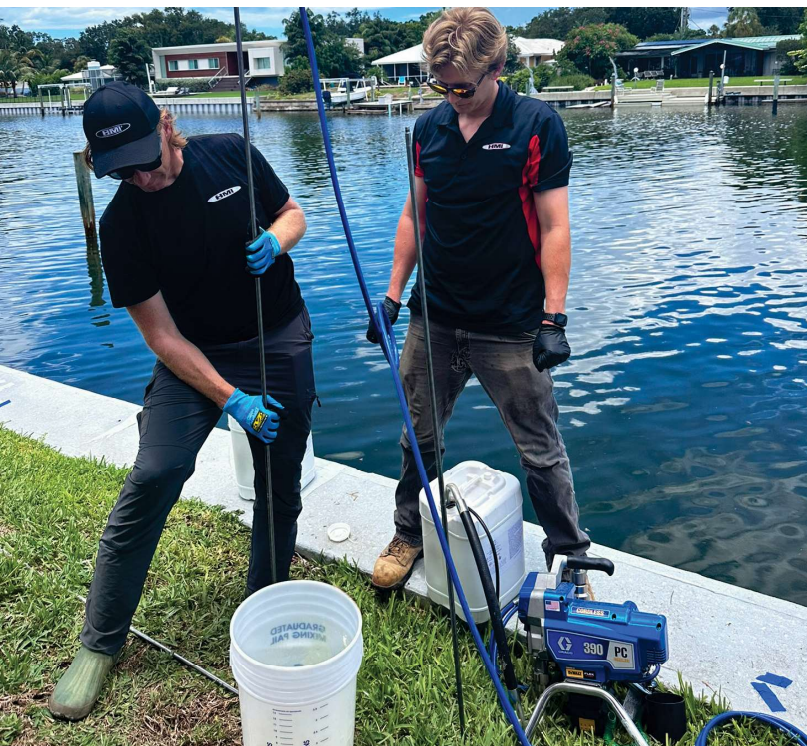
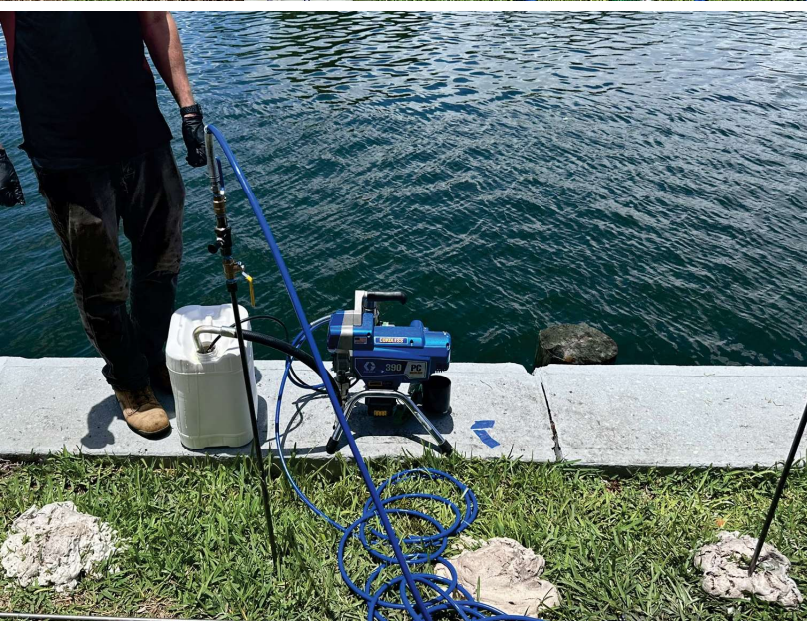
A residential coastal seawall in St. Petersburg, Florida was exhibiting signs of soil loss (soil piping) from underneath the seawall and through gaps or cracks that slowly developed over time. This soil loss resulted in settlement of the retained soil, with very loose soil and small voids encountered at depths from 3 to 6 feet and 7 to 10 feet below the top of grade, which compromised stability of the seawall. A previous stabilization attempt involved the installation of 3 piers driven against the face of the seawall to provide additional lateral support. However, this approach did not address the root cause - ongoing soil loss.

To address the soil piping and stabilize the soil behind the seawall, the decision was made to conduct permeation grouting using a single-component polyurethane foam. This material was chosen for its effectiveness in stabilizing soil, filling cracks and voids, while being minimally invasive with no excavation or large equipment. The ability to adjust the reaction time on-site, through mixing adjustable amounts of catalyst, would allow the material to permeate through the soil, ensuring comprehensive coverage. The permeated material would also penetrate unseen gaps or cracks beneath the waterline before expanding to seal off those channels for soil loss. (As pictured below)
