CASE STUDY - FOUNDATION CRACK INJECTION

Residential home in Manitowoc, Wisconsin

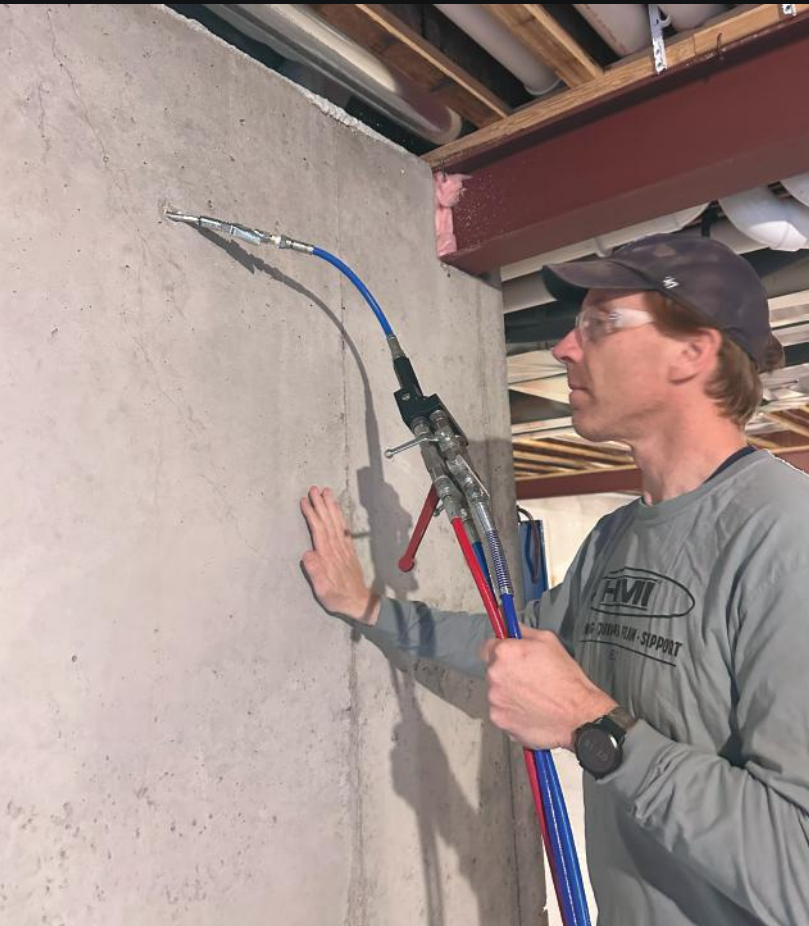
A residential home in Manitowoc, WI, was experiencing persistent water seepage through a thin, nearly full-height crack in the foundation wall. The crack had gradually worsened over time, allowing moisture intrusion, which led to interior water damage. Traditional patching methods had proven ineffective due to the crack's narrow width and depth. The property owner sought a permanent, minimally invasive solution to stop water infiltration and protect the foundation.

HMI@ proposed Soil Link™ Acrylate Grout Injection, an ideal solution for sealing hairline cracks in below-grade structures. The acrylate grout's low viscosity allowed it to penetrate deep into the crack, ensuring a watertight seal. The project followed a precise six-step injection process:

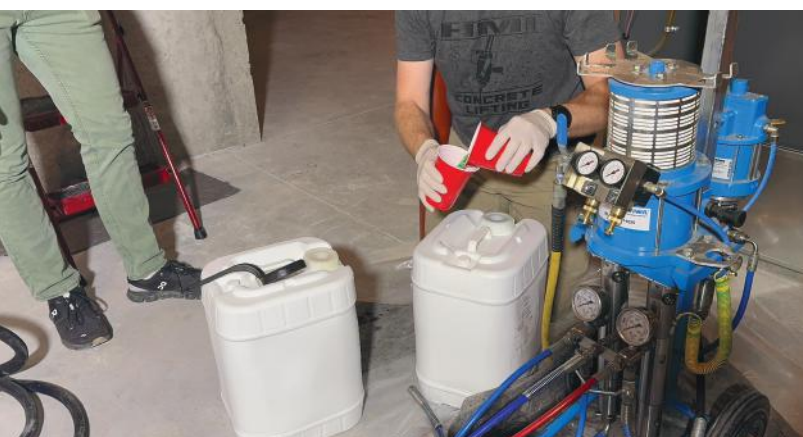
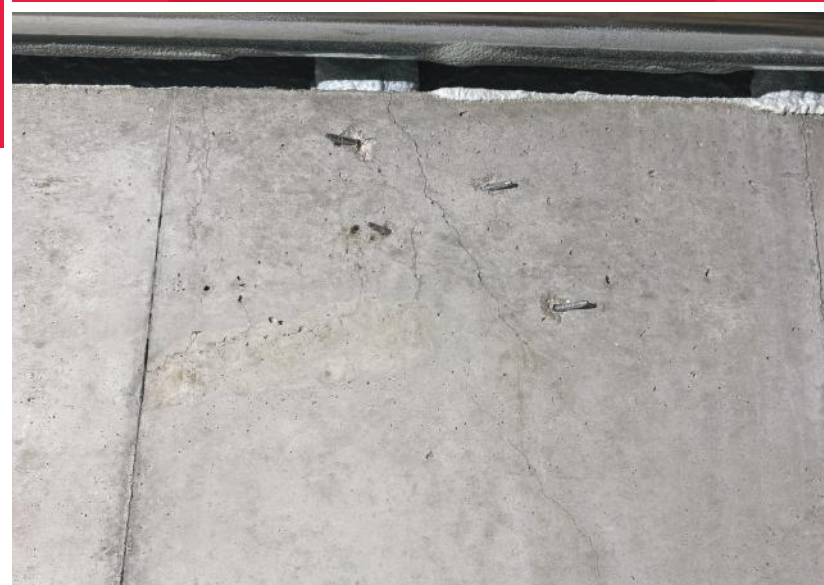
The HMI@ Soil Link™ Acrylate Grout Injection successfully sealed the full-height foundation crack, eliminating water seepage and restoring the basement to a dry condition. The low-viscosity acrylate gel effectively permeated the narrow crack, forming a long-lasting waterproof barrier. Unlike rigid repair materials, the flexible nature of the acrylate grout allows for minor foundation movement without compromising the seal. The use of a pump made the injection process efficient and precise. The project provided a **non-invasive, cost-effective, and permanent** solution, preventing further water damage and giving the homeowner peace of mind.
