## CASE STUDY - GROUND STABILIZATION AT THE UNI DOME ELEVATOR SHAFT EXCAVATION

University of Northern Iowa

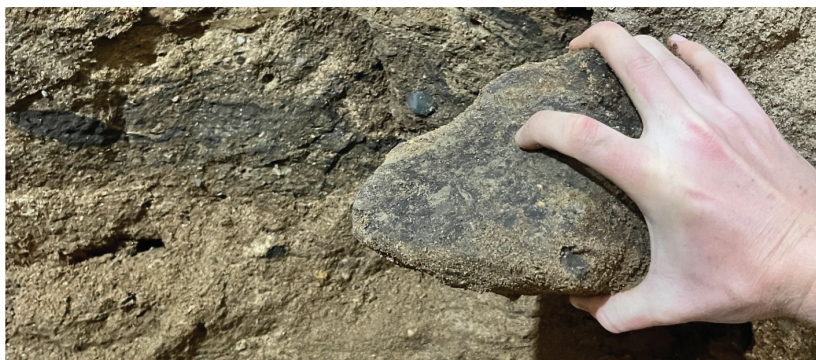
A preliminary soil boring taken near a large column footing suggested ideal conditions: loose, sandy fill with minimal fines, perfect for permeation grouting. However, this soil boring was misleading. The soils adjacent to the footing had been backfilled during the Dome's original construction and did not represent the native soil profile throughout the rest of the excavation.

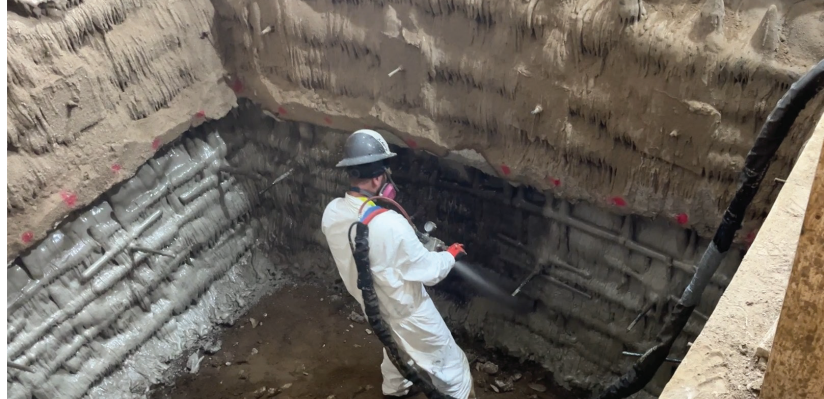
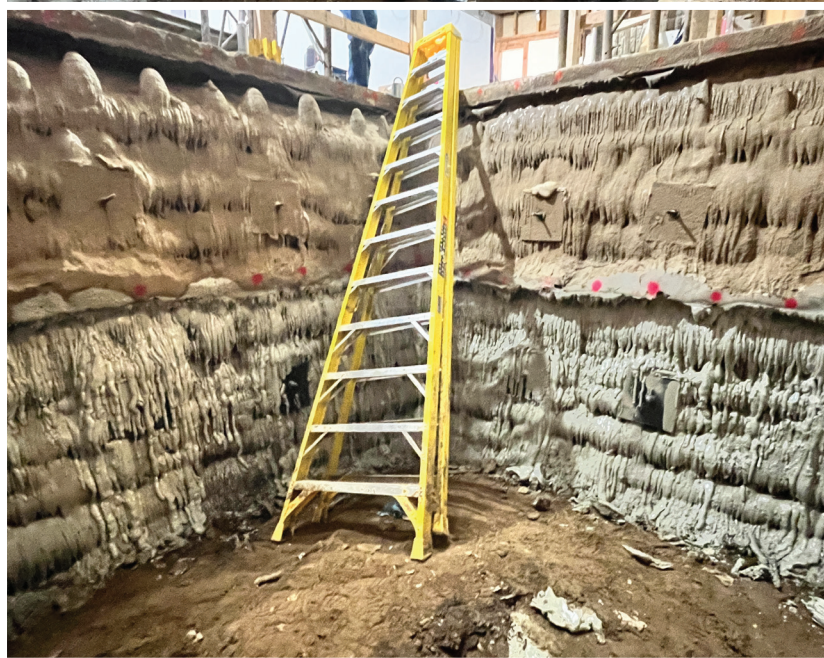
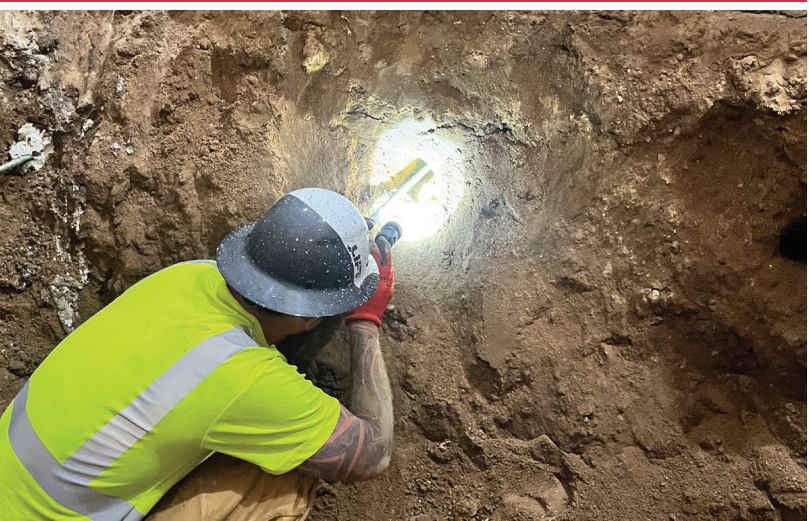
- **Polyurethane-Grouted Soil Nails:** A total of 32 soil nails were installed using HMI 501 polyurethane foam as the bonding medium between the soil and the 5/8-inch all-thread steel bars. Pull tests on the completed nails demonstrated outstanding performance - exceeding the yield strength of the steel bar and surpassing the design load criteria.

- **Structural Facing with Spray-Applied Foam:** To support the excavation face and distribute soil nail head loads, a structural mesh was installed and over-sprayed with HMI 601 polyurethane foam. The foam cured within 30 minutes, forming a strong, uniform facing capable of full load transfer.

- **Top-Down Excavation in Controlled Lifts:** The stabilization system was implemented in 4-foot excavation stages following traditional top-down construction practices. The pre-installed acrylate grout, although not uniformly effective, helped mitigate soil sloughing, particularly near the excavation base where unsupported pressures were greatest.
