CASE STUDY - VOID REMEDIATION – TUNNEL ABANDONMENT BENEATH CHURCH BREEZEWAY ADDITION

Manitowoc, WI

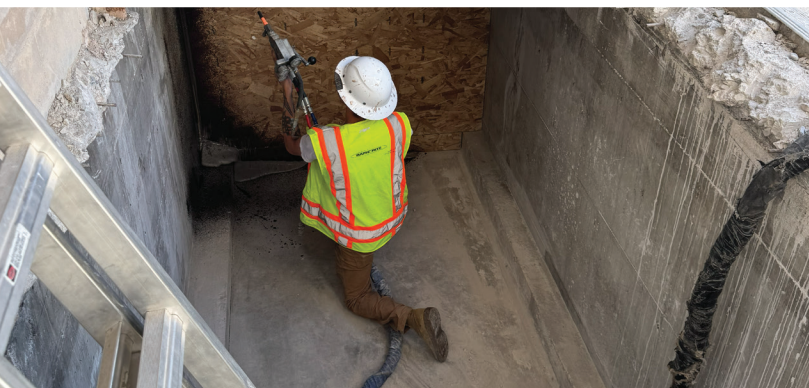
- Large unknown tunnel void beneath a structural transition zone
- Need for stable, uniform load-bearing conditions
- Restricted access preventing traditional backfill methods
- Geotechnical uncertainty regarding settlement and structural integrity
- Tight construction schedule requiring phased work

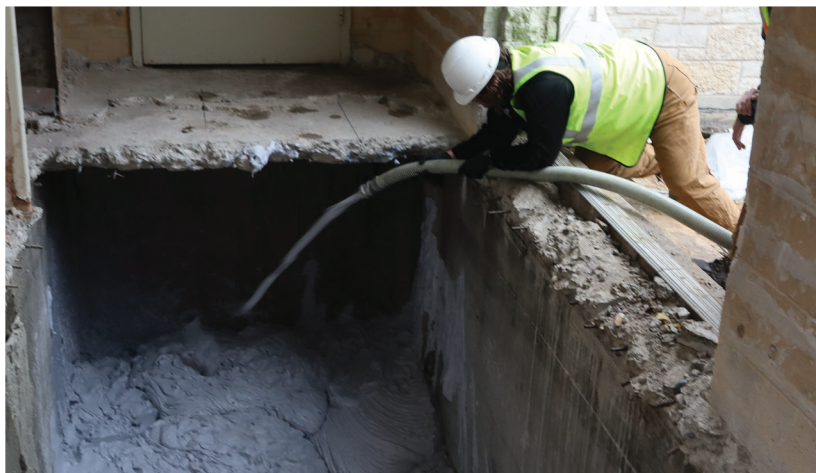
The contractor used a combination of HMI 201 Lightning polyurethane foam and FillFoam™ to fully seal, fill, and stabilize the void. FillFoam™ offered long-distance flow, extremely lightweight placement, and fast curing—ideal for tunnel abandonment and void remediation.

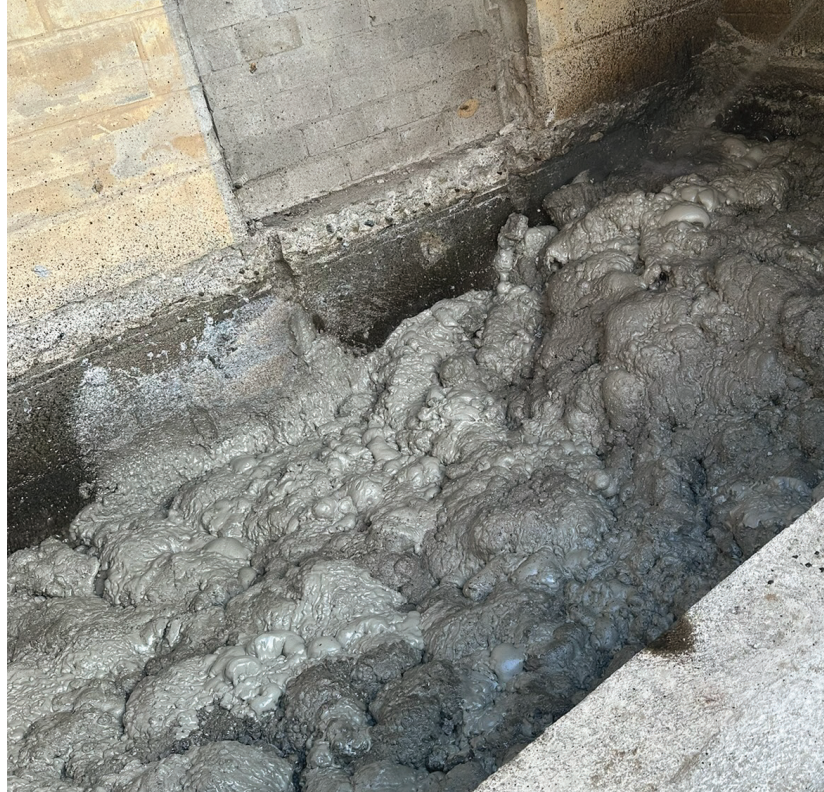
Within one hour 4,500 lbs of FillFoam™ was installed into the approx. 6' x 6' x 14' tunnel, producing the volume of 20 cubic yards, starting from the rear and filling forward to achieve complete cavity encapsulation.

200 lbs of HMI 201 Lightning polyurethane foam was applied to cap the FillFoam™ mass and create a rigid sealed surface suitable for the new slab.

After capping was complete, the job site was ready for the concrete ramp installation. It was recommended that the new concrete slab be doweled into the existing foundation to improve structural support above the former tunnel.

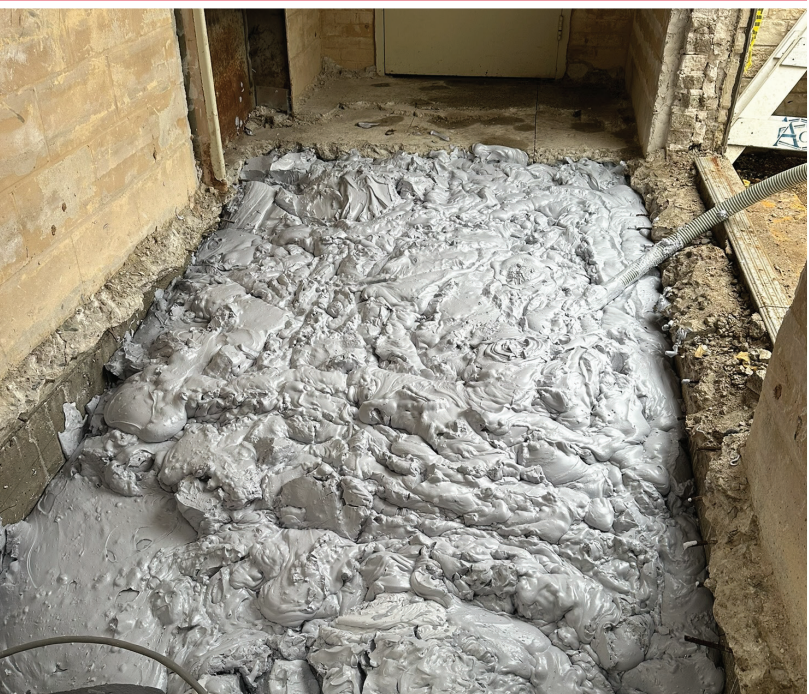
- Avoid trucking in several cubic yards of traditional fill
- Reduce fuel consumption and overall environmental load
- Minimize job-site disruption and equipment footprint
- Lower worker exposure to confined or potentially unstable underground spaces
- Eliminate dust and debris associated with traditional soil movement
