CASE STUDY - GOAT CAROUSEL MILKING PAD STABILIZATION

Wisconsin

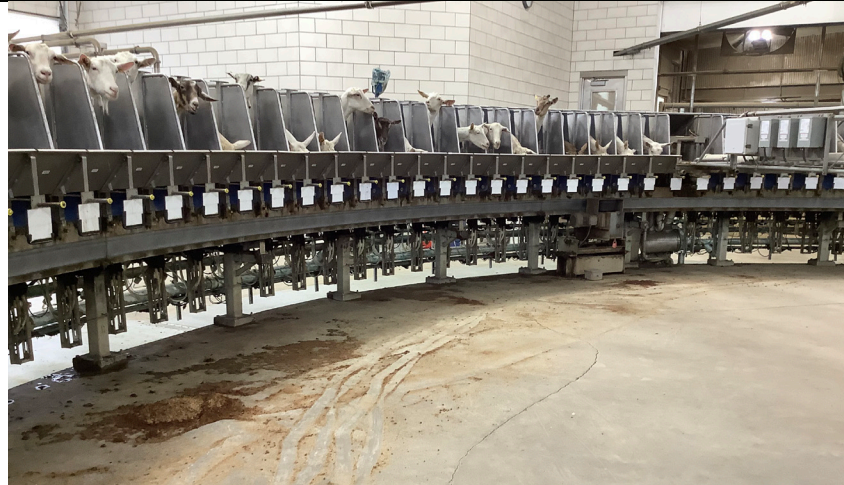
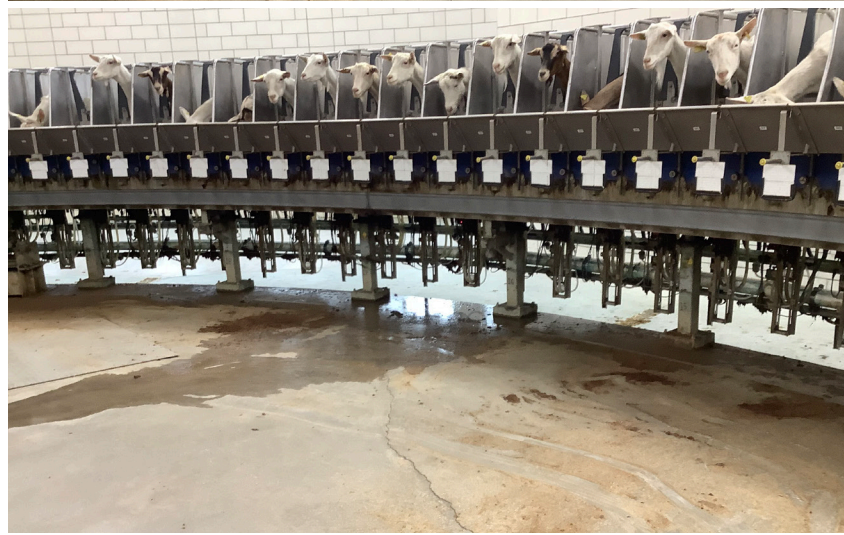
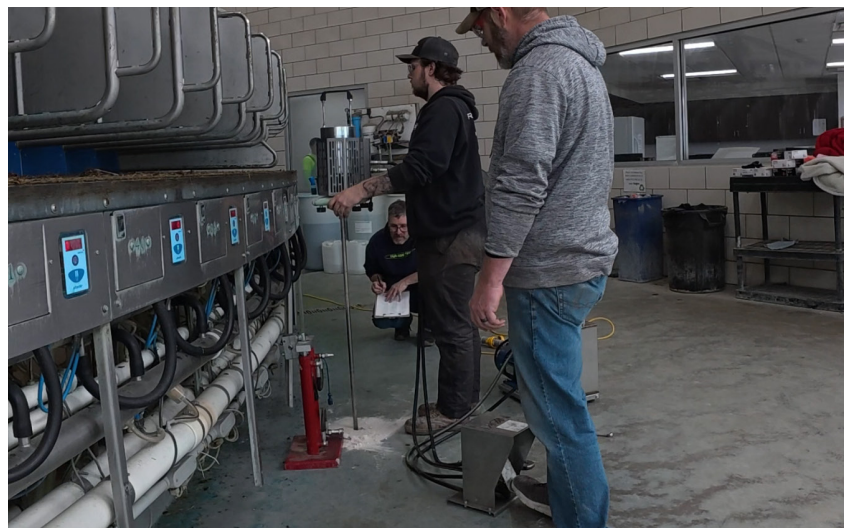
A carousel milking pad at an active livestock milking facility was experiencing movement and cracking due to consolidation of the gravel and soil beneath and around the pad.

As the supporting material continued to consolidate, the pad became uneven. This created alignment issues with the carousel system and caused rollers to wear prematurely. Left unaddressed, the continued movement could have led to increased maintenance costs, additional equipment wear, and greater disruption to daily operations.

Dynamic Cone Penetrometer testing was performed at four locations to help verify soil conditions, confirm treatment depth, and guide the final injection plan.

The contractor used HMI's Deep Foamjection™ method to stabilize the carousel pad by performing deep injection of 4 lb. HMI polyurethane foam beneath the slab and into the supporting soils.

The revised plan used 32 air-purged deep injection points spaced approximately 3.5 feet on center. Each point was treated to a depth of approximately 4 feet, with 4 lb. HMI foam injected incrementally to help densify and stabilize the supporting soils while managing lift response and minimizing risk to surrounding features.

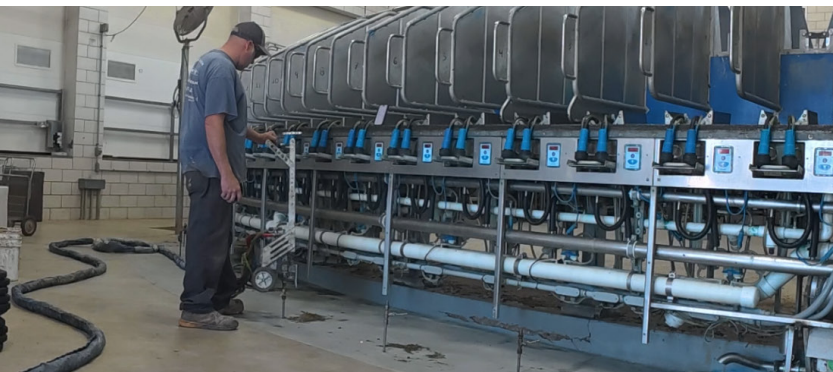
By working in controlled stages, the crew was able to address the underlying soil and gravel consolidation while accounting for sensitive site conditions and the operational demands of the facility.
