## CASE STUDY - MILKING CAROUSEL PEDESTAL BASE STABILIZED WITH HS030 SINGLE-COMPONENT GROUT

Wisconsin

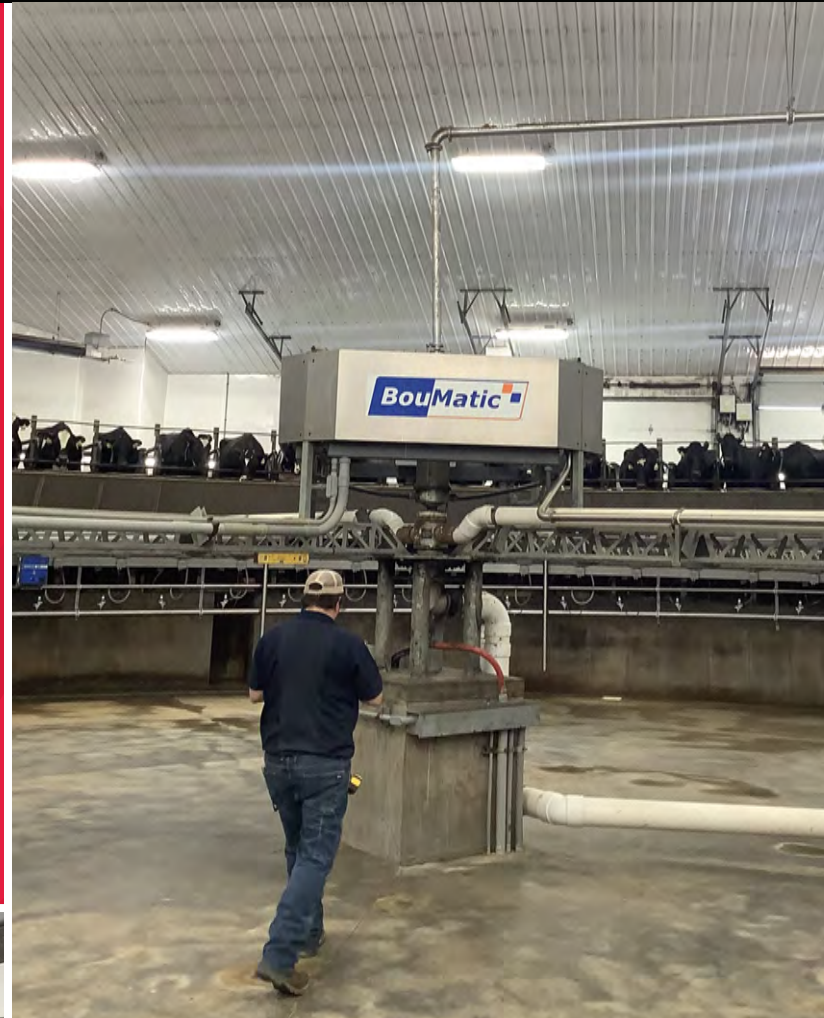
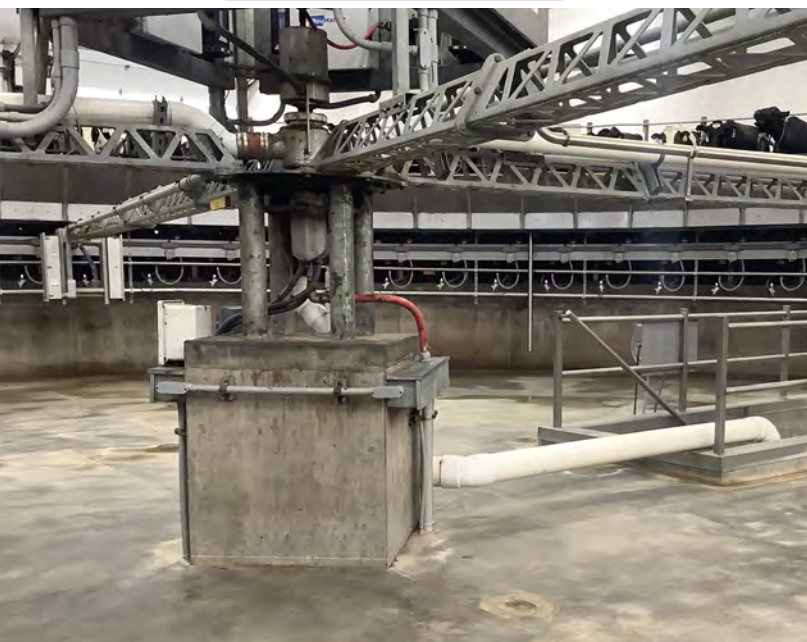
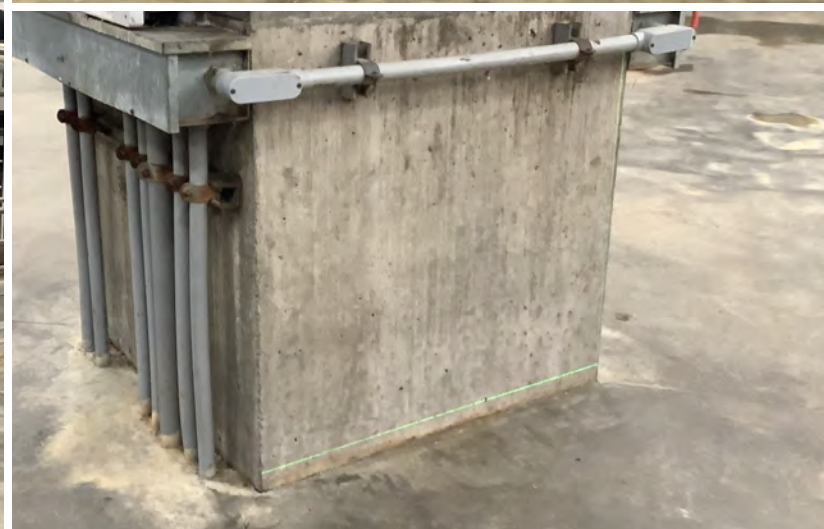
A Wisconsin dairy farm was experiencing settlement at the center pedestal base of a cow milking carousel. The base had settled slightly to one side, approximately 1/8 to 1/4 inch, which was enough to create minor misalignment in the overhead carousel mechanism.

The underlying soil was sandy and coarse-grained, making it a good candidate for permeation grouting.

To stabilize the pedestal base and help prevent further settlement, HMI's HS030 single-component grout was used to permeate the sandy soil beneath the affected side of the carousel base.

The grout was injected through 9 points on the side of the pedestal experiencing settlement. Approximately 600 lbs. of HS030 was installed to help bind and stabilize the coarse-grained soil beneath the base.
