## HOTEL EXPANSION STAYS ON SCHEDULE WITH ACRYLATE GROUT SOIL STABILIZATION

Wisconsin

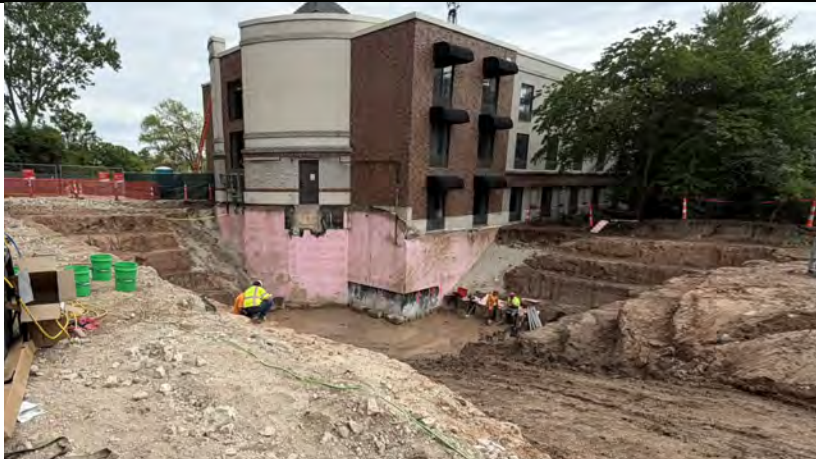
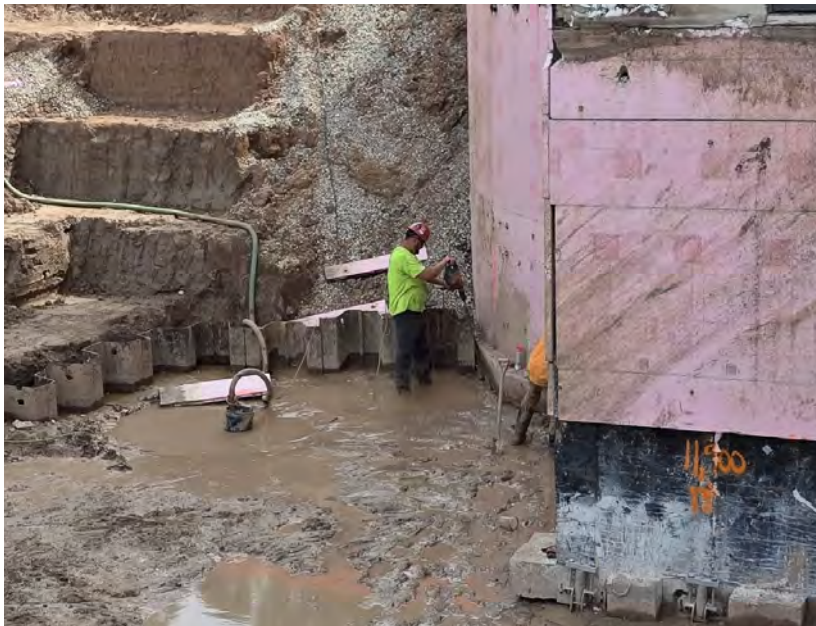
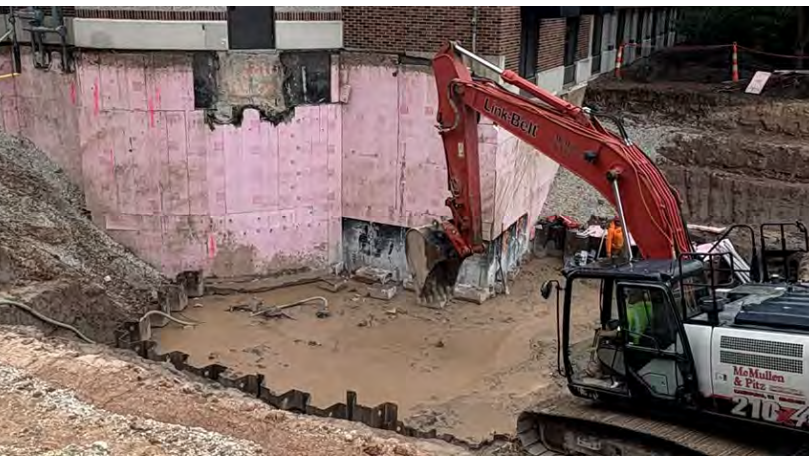
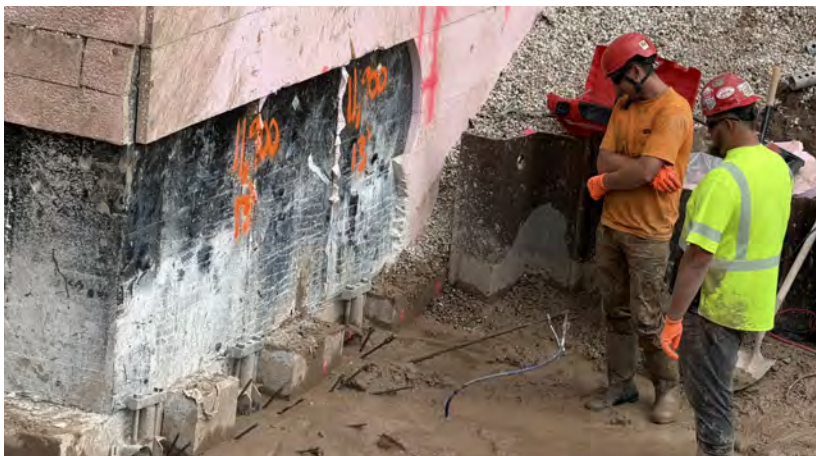
The planned excavation was located directly alongside the existing hotel foundation. Once exposed, the loose granular soils could slough from beneath the footing, compromising support for the existing structure.

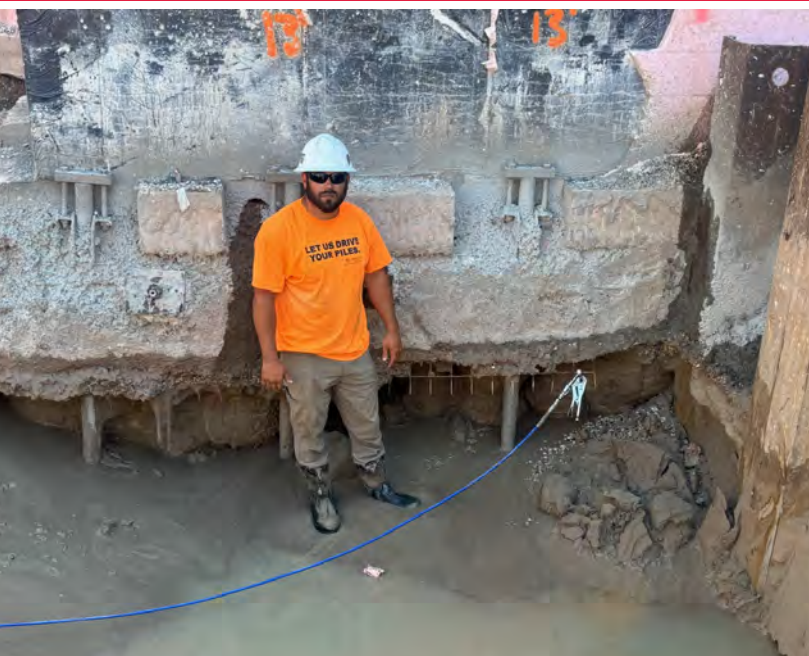
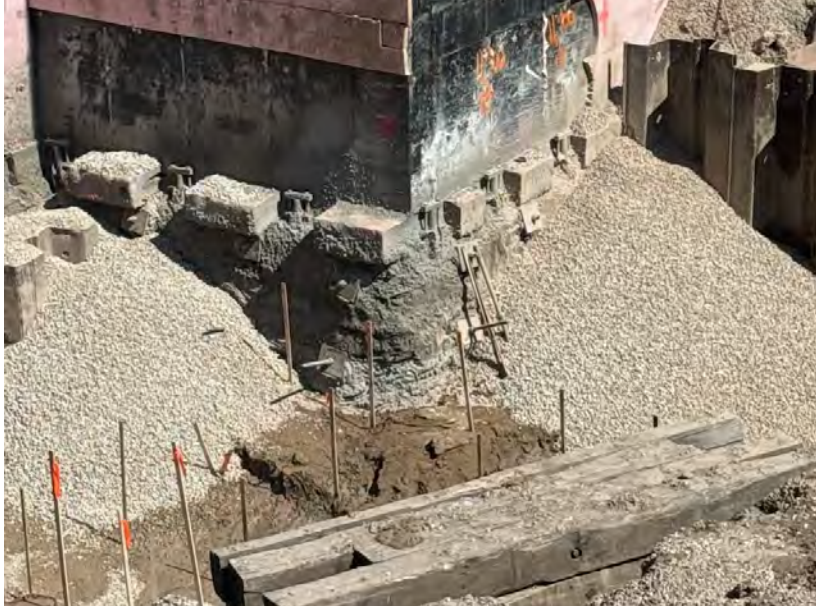
The contractor then injected 675 gallons of HMI AG100 Acrylate Grout beneath the footing at multiple angles following the engineered grouting plan. After excavation was complete, grouted soil nails and shotcrete were installed to stabilize the excavation face while helping prevent buckling of the exposed helical pile shafts.
