Case Study

DuBois Machine Company Void Fill

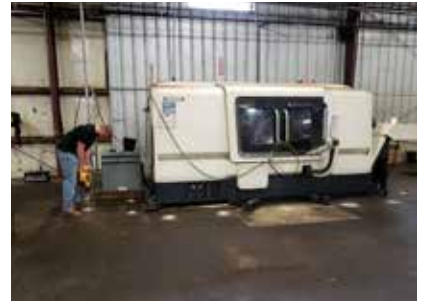
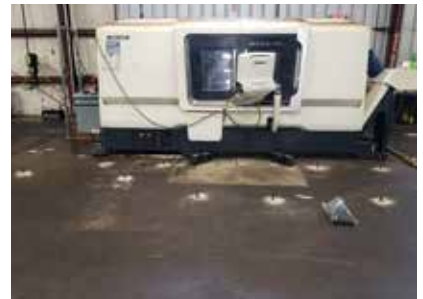
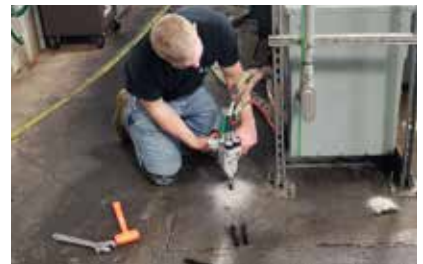
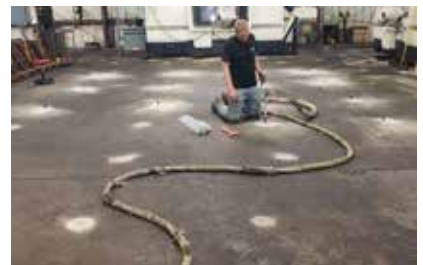
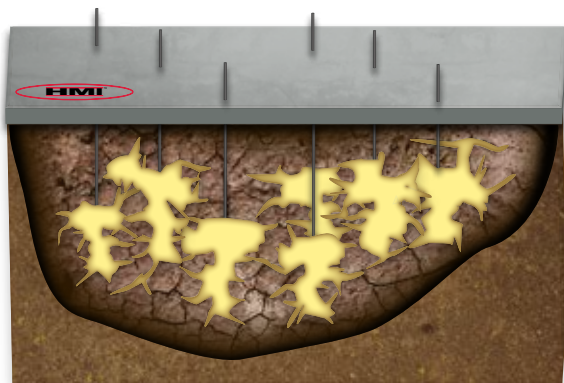
A one inch void was found under the slab due to erosion; The shop was built on marshland. This allowed for no support causing the slab to deflect significantly.

The local concrete lifting company was called and the work was completed in 6 hours. Using the EliteOne gun and HMI's 501 polyurethane foam the void was filled, which stabilized the concrete slab. 501 polyurethane foam was chosen for this job because it provides a slower reaction time and further spread. Due to the distance this foam can travel, 501 is excellent for undersealing and stabilizing joints on rocking slabs from slab curl. The same dial gauge test was performed after the foam was injected, and showed no deflection. The CNC's were re-leveled and operations continued. The only alternative would have been to tear out, and replace the entire slab. Which would have affected production greatly. By choosing to fill the void, they were able to continue production immediately following the repair.

853 lbs of HMI 501 stabilizing polyurethane foam
