## CASE STUDY - FAILING SEA WALL SOILS REPAIRED AT MINIMAL COST & NO EXCAVATION

St. Petersburg, Florida

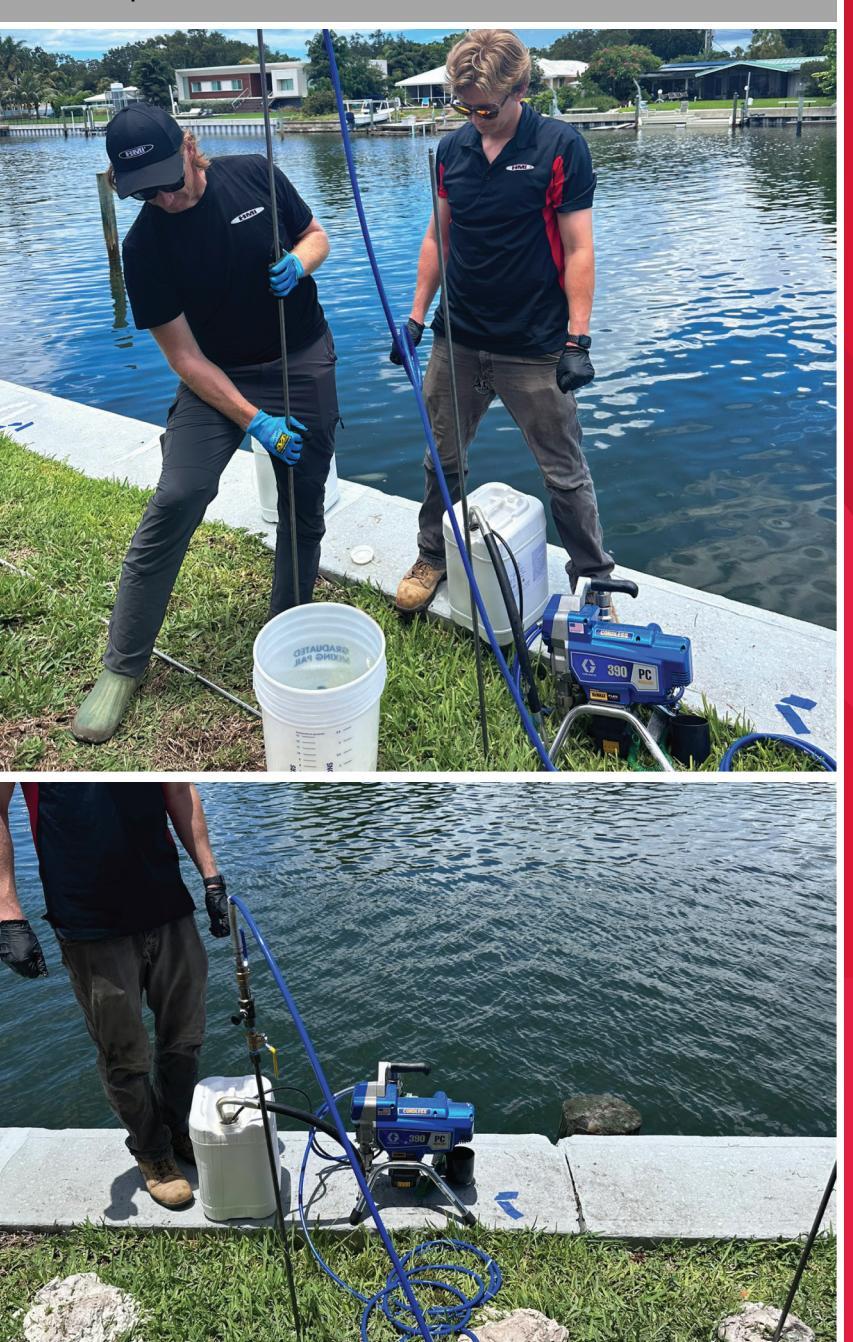
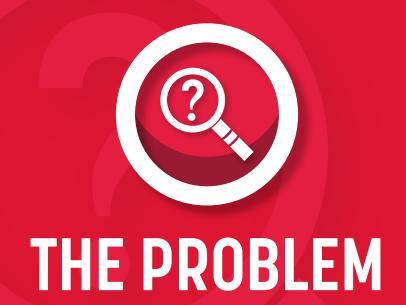
A residential coastal seawall in St. Petersburg, Florida was exhibiting signs of soil loss (soil piping) from underneath the seawall and through gaps or cracks that slowly developed over time. This soil loss resulted in settlement of the retained soil, with very loose soil and small voids encountered at depths from 3 to 6 feet and 7 to 10 feet below the top of grade, which compromised stability of the seawall. A previous stabilization attempt involved the installation of 3 piers driven against the face of the seawall to provide additional lateral support. However, this approach did not address the root cause - ongoing soil loss.

The situation was further exacerbated over time by the large tidal fluctuations common to the area, which continued to pipe soil through and beneath the seawall. The initial proposed repair solution was to replace the seawall or to continually backfill the settled areas behind the wall with seashells throughout the lifespan of the structure. A cost-effective ground improvement solution of foam injection behind the seawall was proposed, aimed to prevent further soil loss, increase stability of the retained soil, and extend the lifespan of the seawall.

To address the soil piping and stabilize the soil behind the seawall, the decision was made to conduct permeation grouting using a single-component polyurethane foam. This material was chosen for its effectiveness in stabilizing soil, filling cracks and voids, while being minimally invasive with no excavation or large equipment. The ability to adjust the reaction time on-site, through mixing adjustable amounts of catalyst, would allow the material to permeate through the soil, ensuring comprehensive coverage. The permeated material would also penetrate unseen gaps or cracks beneath the waterline before expanding to seal off those channels for soil loss. (As pictured below)
