CASE STUDY - WATERPROOFING A CRITICAL TELECOMMUNICATIONS FACILITY

• Yorkton, Saskatchewan - Canada •

PRODUCT USED: HMI SOIL LINK™ ACRYLATE GROUT

APPLICATION: Crack Sealing & Water Infiltration Prevention.

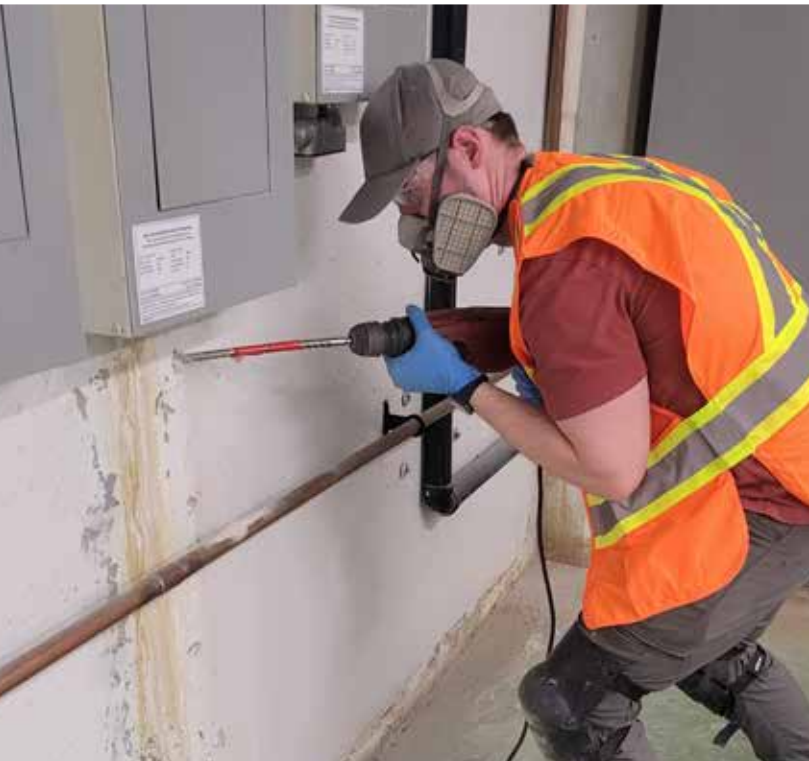
A telecommunications switching station was facing chronic groundwater infiltration that threatened highly sensitive electrical equipment. The water intrusion stemmed from foundation settlement and was traced to four significant cracks in the structure's thick concrete walls:

- Two full-length cracks (10 feet each)
- Two six-foot cracks, one of which was actively leaking

Due to the age of the wall, thickness, and the need for a permanent solution without error to protect sensitive electrical equipment, a geotechnical engineer recommended HMI's Soil Link™ Acrylate Grout to provide a watertight seal.

The cracks were successfully sealed with HMI's Soil Link™ Acrylate Grout stopping water infiltration in its tracks. After an acid base flush cleaned out dirt, organics and debris, the low-viscosity acrylate gel effectively permeated the narrow and leaking cracks, forming a long-lasting waterproof barrier. Thus, effectively protecting the sensitive electrical equipment and solving the problem.
