Sweden Case Study

Deep FoamjectionTM

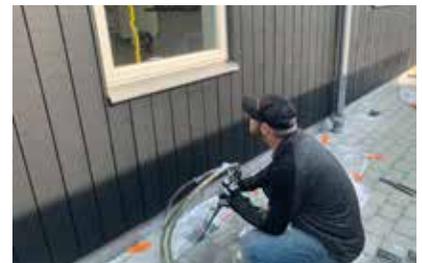
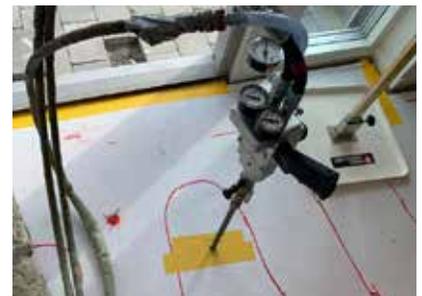
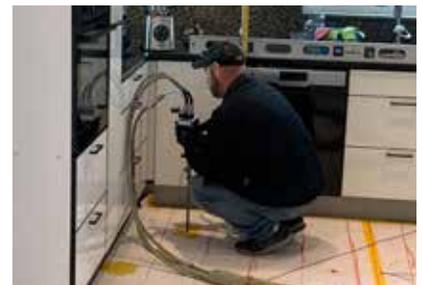
Project's Blueprint

This map identifies that areas where material was injected to stabilize and lift the slab. The areas in red received the most foam where the slab was raised up to 3 ½ inches. The yellow and green areas supported the lift and stabilized the slab.
