Seawall/Bulkhead Repair Case Study

Using Deep Foamjection™

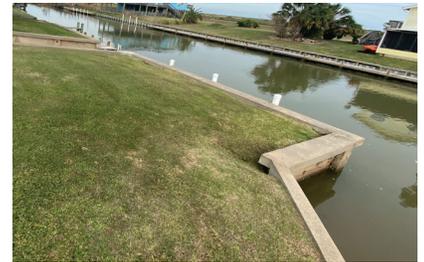
An HMI customer was contacted by a gentleman looking for options to repair his failing concrete seawall for his bay home in Matagorda, TX. The home was located on a canal which connects directly to the Gulf Intracoastal Waterway. The non-stop commercial traffic, consisting of tugboats pushing massive 300-ton steel barges, created a constant displacement of water in the canal which caused the concrete seawall to deteriorate and allow water infiltration. Due to this continuous water movement, the base soils were washed out and voids began to develop below the seawall. Once the support soils were lost, sinkholes and settlement of soils along the seawall became apparent. As shown in the picture to the right.

Sunken Landscape

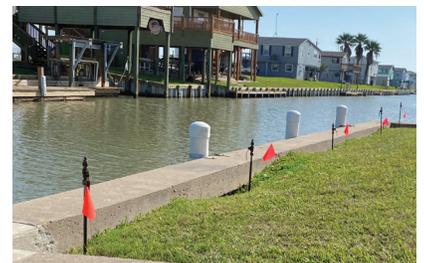
Deep Foamjection™ Pipe

The Deep Foamjection™ process was used to stabilize the soils and prevent further erosion and loss of soils without excavating or damaging the seawall. Deep Foamjection™ is the process of injecting high density foam to specified depths to reestablish and increase the load-bearing capacity of the soils. The material used for this project was HMI's expansive polyurethane 402-Hydrofoam. Hydrofoam was chosen due to its unique hydro-insensitive polymers that aggressively seek out voids and maintain dimensional stability in wet environments. For this project, 21 injection points were installed along the seawall at depths of approximately 3ft and 6ft under the ground. The entire process was quoted at \$9,500 and completed in a day and a half, providing the customer a timely and cost effective solution.
