# Case Study

## Gymnasium Repair

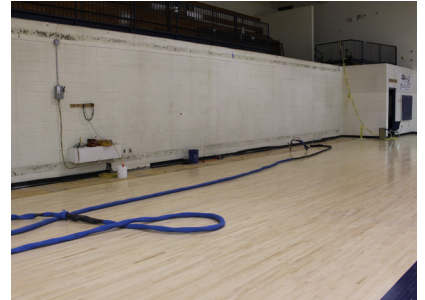
Before

The Sault Area High School in Sault Ste. Marie, Michigan was refinishing their gymnasium floor and installing new bleachers. Upon removal of the old bleachers it was discovered that the gymnasium floor had settled along the west wall. RaiseRite Concrete Lifting (HMI's Contracting Division) was referred to by an outside engineering firm to repair the sunken floor. An appointment for inspection of the area was made and it was determined that ninety feet of the floor had settled one and a half inches. Because the wood floor could not be removed it was decided that HMI 401 high density polyurethane foam would be used to lift the concrete. An estimate for the repair was written the next day and later approved by the high school. A few weeks later a RaiseRite crew was on-site ready to perform the work.

RaiseRite crew members drilled two sets of 1" holes through the wood gymnasium floor to reach the concrete slab underneath every 5 feet apart. Crew members then drilled 5/8" holes through the concrete. A total of 520 lbs. of high-density 401 foam was injected through the holes where it started to expand and gradually raised the floor back to its original height. Work was completed in less than 8 hours and was immediately ready. Floor refinishers then came in and repaired the 1" holes as part of their refinishing process. New bleachers were soon installed afterwards and the floor was ready for use at the start of the new school year.
