CASE STUDY - POWER POLE STABILIZATION USING DEEP FOAMJECTION™

Canada

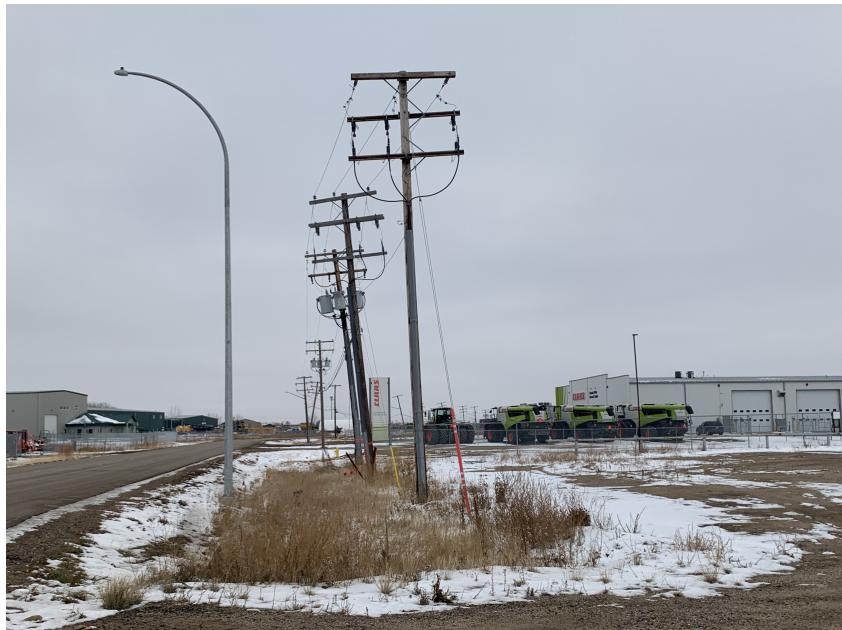
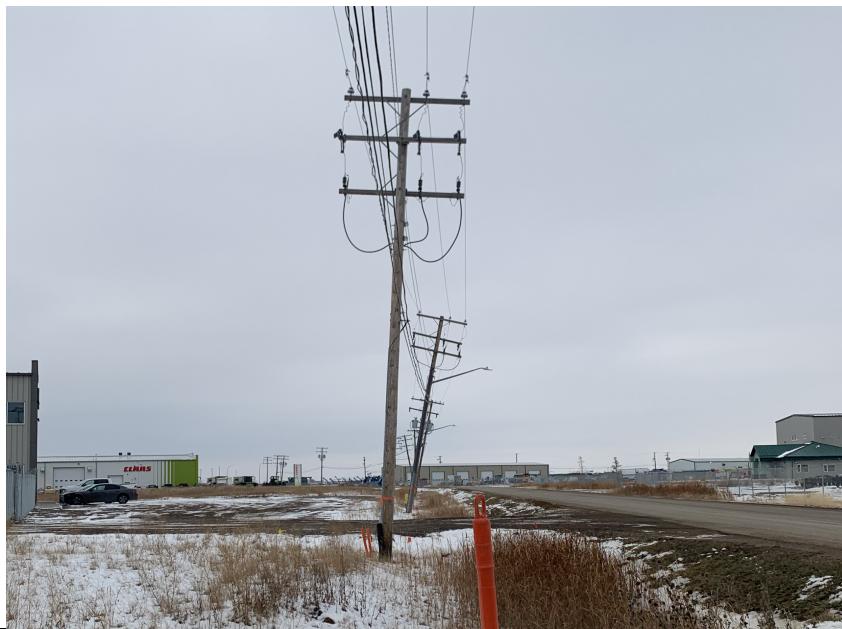
The affected poles were gradually leaning due to weak, moisture-impacted soils and erosion along the ditch line. Because of safety requirements, the power company's crews needed to bring the poles back to plumb using their approved equipment and procedures. The challenge was ensuring that the restored alignment would be maintained over time in a high groundwater environment.

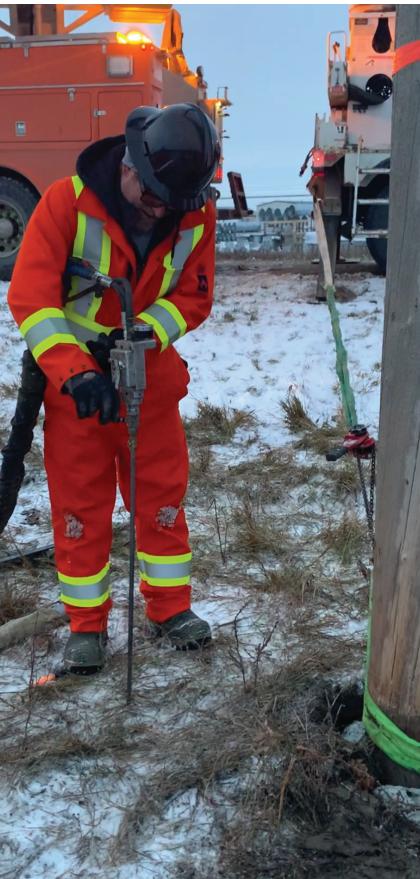
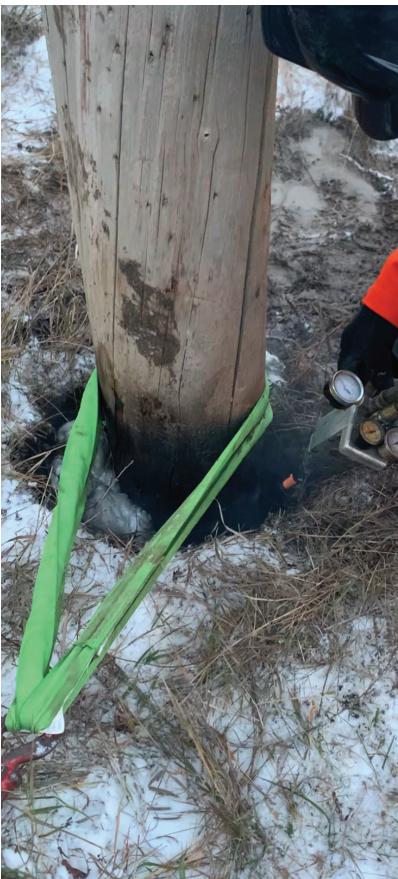
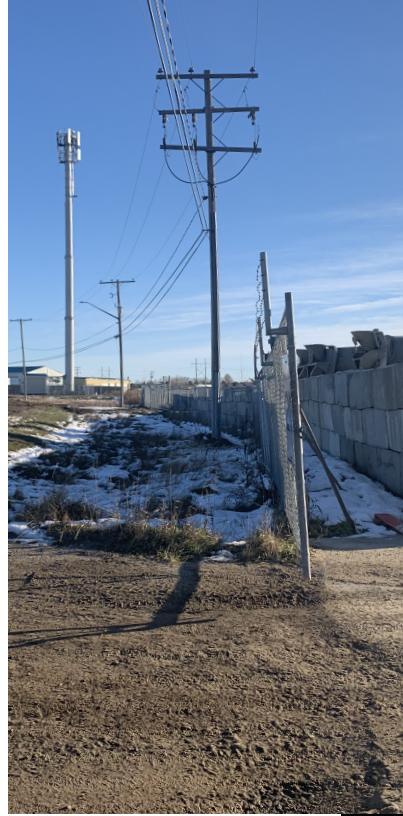
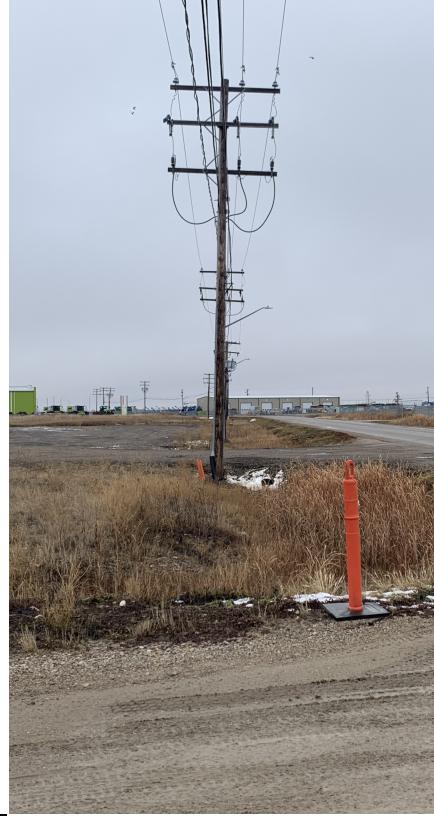
HMI supported a polyurethane foam soil improvement process that complemented the power company's pole-straightening procedures. After the power company's crews restored each pole to plumb, foam was injected to:

- Fill voids created during hydro-excavation
- Densify and strengthen weak soils surrounding the pole
- Improve long-term resistance to movement in saturated conditions

- Polyurethane material used: 227.08 lbs (HF 402)
- Time on site per pole (completion): approximately 1 hour
- Total poles stabilized: 15
