## CASE STUDY - ELECTRICAL SUBSTATION SLAB LIFT

Canada

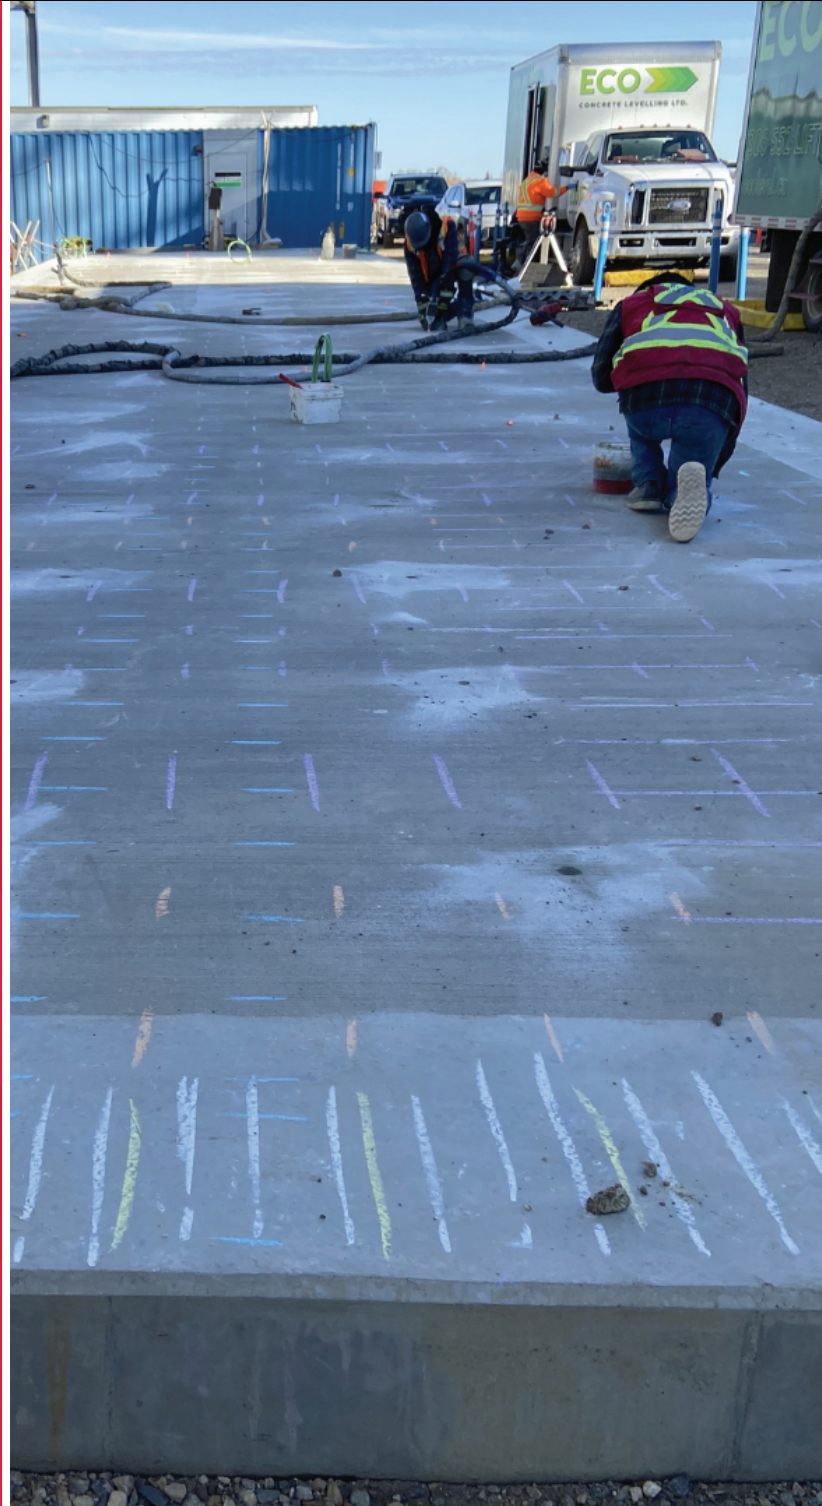
During construction of an electrical substation, engineered elevation specifications were communicated incorrectly. The concrete slab was poured well and remained structurally sound, but the finished elevation was approximately 2-3 inches too low.

- **Massive load conditions:** the slab alone was 955,742 lbs, or 478 tons.
- **Large footprint:** 20.72 ft wide by 111.22 ft long
- **Thick structural section:** 31 inches
- **Dense reinforcement:** the slab contained 3 rows of rebar at 4 inches on-center.
- **Precision elevation correction:** lift 2.4 inches
- **Schedule pressure:** a full replacement would have pushed construction into the next spring instead of keeping the project near its regular schedule.

ECO Concrete Leveling used HMI 402 Hydrofoam to raise the electrical substation slab in a controlled, staged injection process.

Because the pad contained a significant amount of reinforcement, the injection pattern and spacing were dictated by concrete scanning. A standard hole pattern was not practical. Instead, injection locations were selected around the scan results to avoid the dense rebar layout while still placing material in the zones needed to create controlled lift.

The ECO crew injected 1,718 lbs of HMI 402 Hydrofoam beneath the slab. Material was injected incrementally while the crew monitored slab movement, allowing the lift to be adjusted as the foam expanded and built support below the concrete.
