## CASE STUDY - FILLFOAM USED FOR STORM PIPE ANNULAR GROUTING

Wisconsin

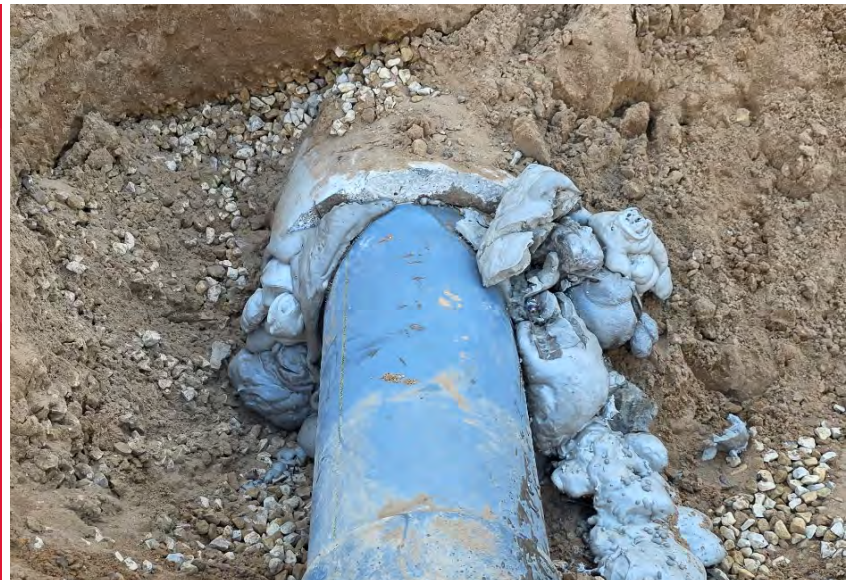
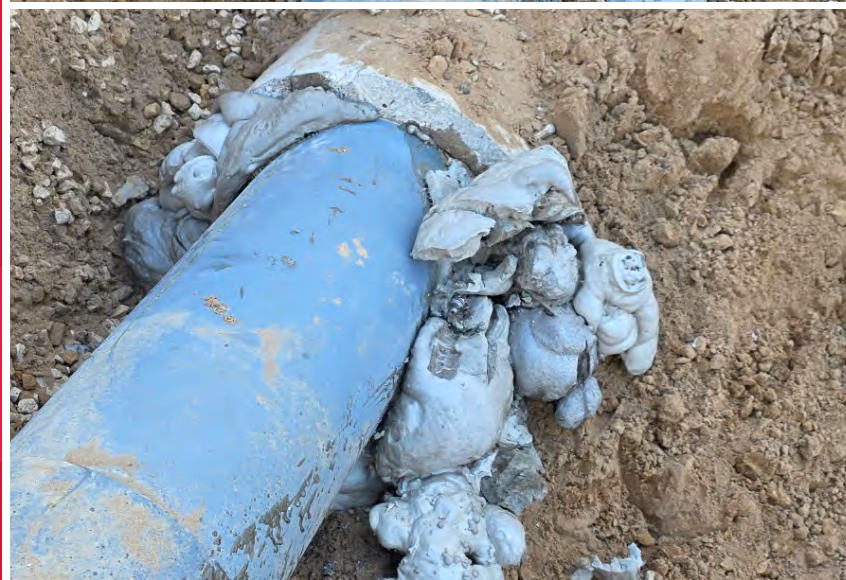
- Fill the annular space between an existing 18-inch concrete host pipe and 13-inch liner
- Reach the full approximately 40-foot length of the pipe
- Fill irregular voids created by deterioration of the existing concrete pipe
- Provide support around the new liner
- Help prevent unintended water movement through the annular space
- Be installed efficiently without removing the existing pipe or creating additional excavation

Because the pipe run was approximately 40 feet long, a placement hose was extended through the annular space to the far end of the pipe. FillFoam was produced onsite and pumped through the hose. As material was placed, the hose was progressively withdrawn, allowing the annular space to be filled along the length of the pipe rather than attempting to push material through the full 40-foot run from a single injection point.

Once placement was complete, the accessible end of the annular space was sealed with a spray-applied bulkhead made with HMI dual-component polyurethane foam. FillFoam's lightweight, pre-expanded formulation made it well suited for filling the irregular annular void while avoiding the additional weight associated with traditional cementitious fill materials.

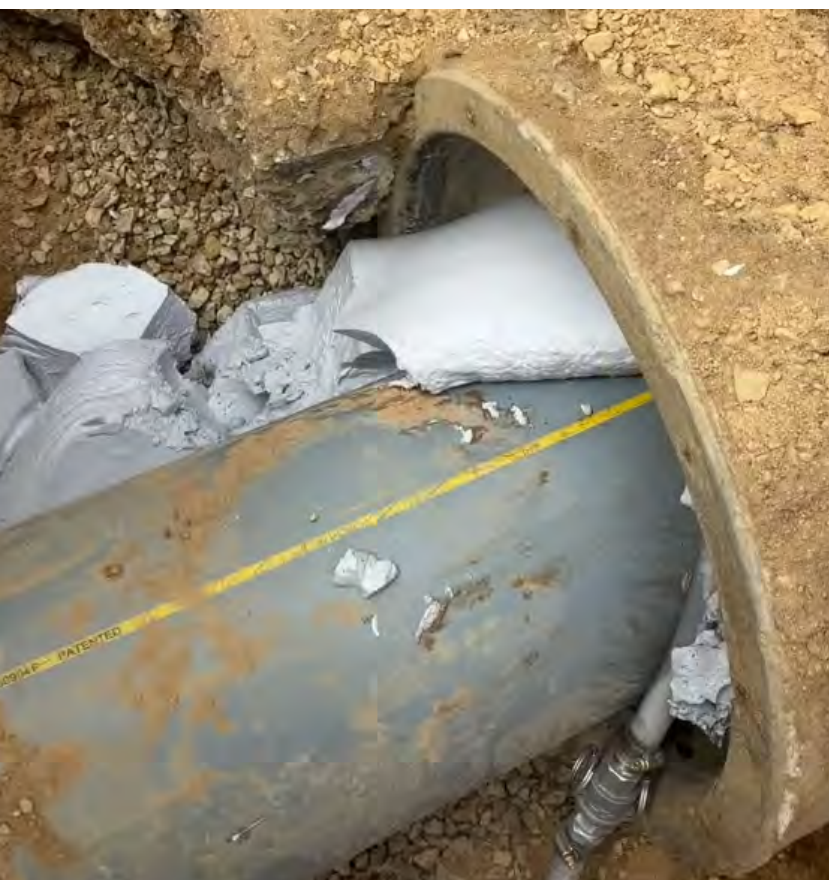
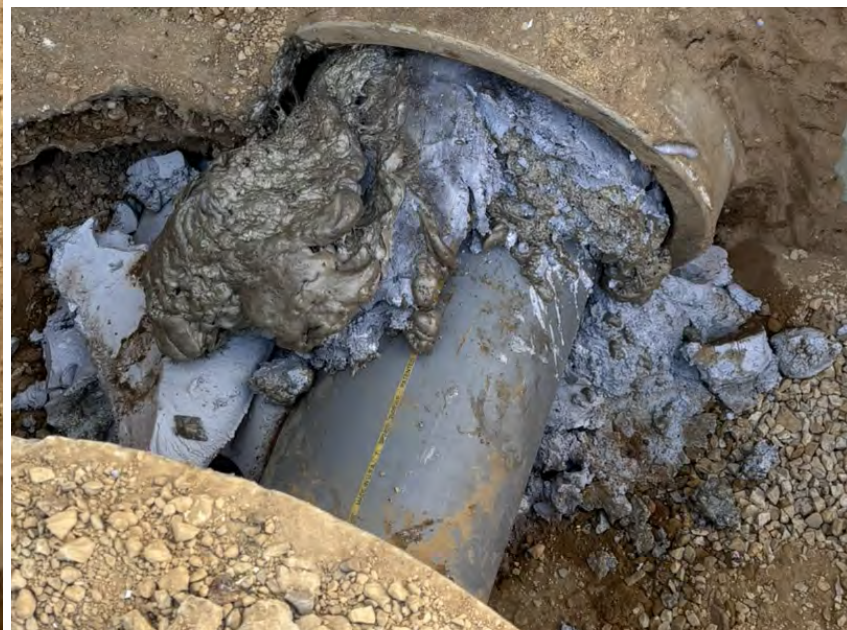
- Approximately 40 feet of annular space filled
- Existing deteriorated concrete pipe remained in place
- New liner supported within the existing host pipe
- Irregular void space surrounding the liner filled
- Open annular pathway for potential water movement addressed
- No extensive removal of the existing storm pipe required
- FillFoam produced onsite for an efficient installation

This project demonstrates how FillFoam can be used for annular grouting applications where new infrastructure is installed within an existing pipe or conduit. By producing the material onsite and placing it progressively through a retractable hose, the project team was able to fill the annular space along the approximately 40-foot run without removing the deteriorated host pipe. For pipe rehabilitation, abandonment, backfill, and other large-void applications, FillFoam provides a lightweight solution that can be produced onsite and placed where conventional fill materials may be difficult or disruptive to install.
